TWO BIRDS, ONE STONE

What is the potential that lies in abandoned agricultural building? Buildings that have lost their initial function and use, and their need to transform to stay "alive". Keeping the notion of the cultural history while applying modern standards.

Case: KRONMOGARDEN

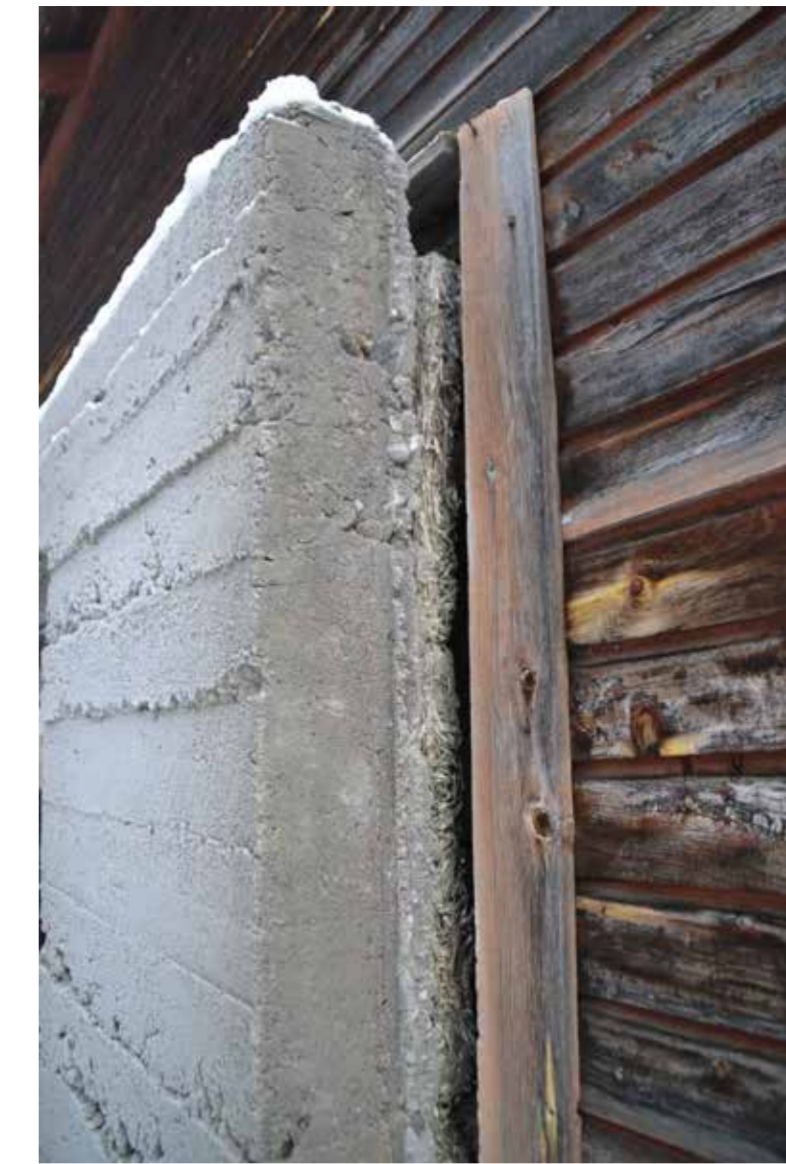
1. The concrete wall

The room that previously housed the cows and sheep has an insulated concrete wall surrounding it. As seen in the picture to the left the wall has started to fall out. It is common in abandoned barns that these walls quickly decay, due to variation in temperatures. The conclusion is that it should be removed in its entirety and be replaced by a new structure that can support the structure above.

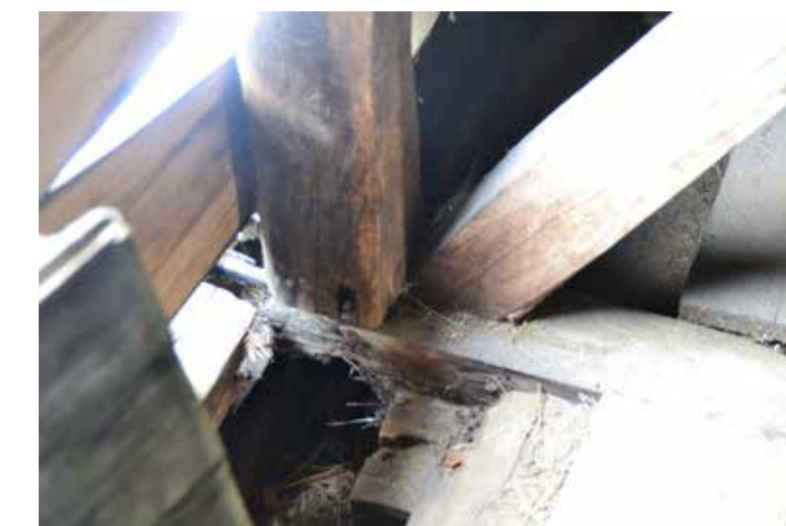
2. Loadbearing beams

The movement of the concrete wall has allowed water to enter the structure. As a result the loadbearing wooden beams show signs of rot. Only the ends of the beams seem affected. One could try to mend the damage or change the beams completely.

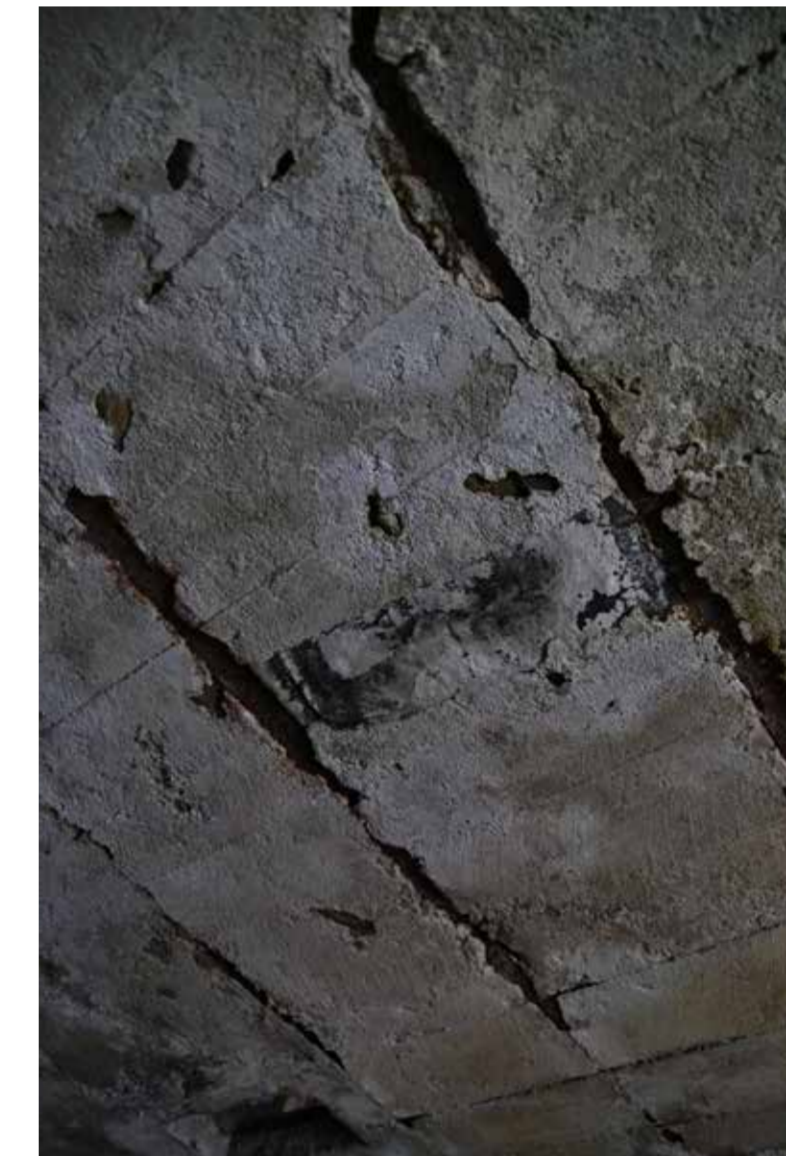
3. Concrete floor

The barn has partially a concrete floor, primarily in relation to the animal rooms. It is not insulated and has visible cracks in a number of places. The preferred solution is to remove the existing floor and replace it with a new insulated floor.

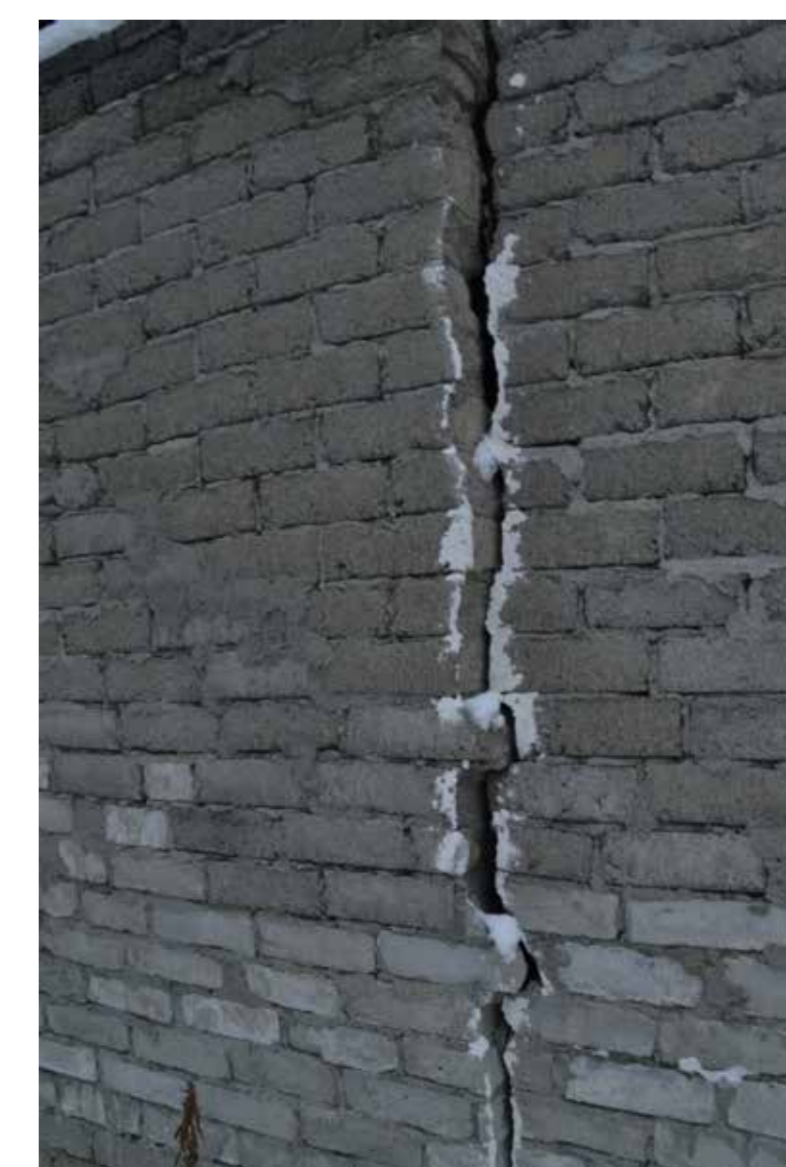
4. The brick wall

The brick wall in the stables is crumbling with large visible cracks. It is not considered a loadbearing wall, but it is possible that water may have reached the constructive wood in between the brick layers. The wall should be torn and replaced.

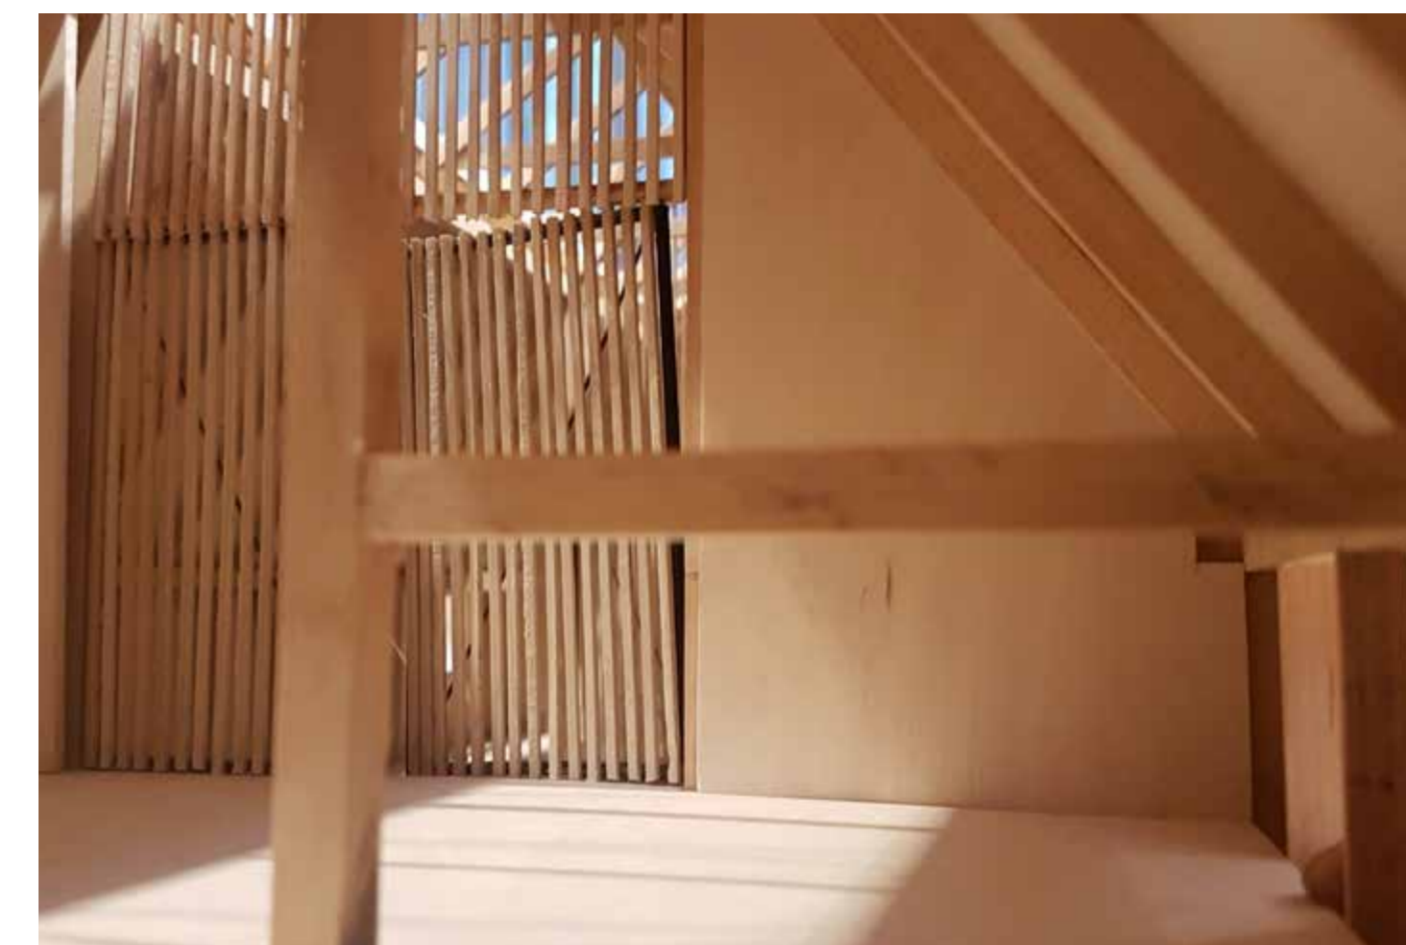
After

The picture shows how a transformation of this barn may appear. The solution tries to keep some of the barn's openness while still being able to close off the individual rooms.
