STUDIO HOUSING IN AKERSVEIEN
- New development in a historical context

Josefine Hauknes
Supervisors: Neven Fuchs-Mikac & Julie Aars

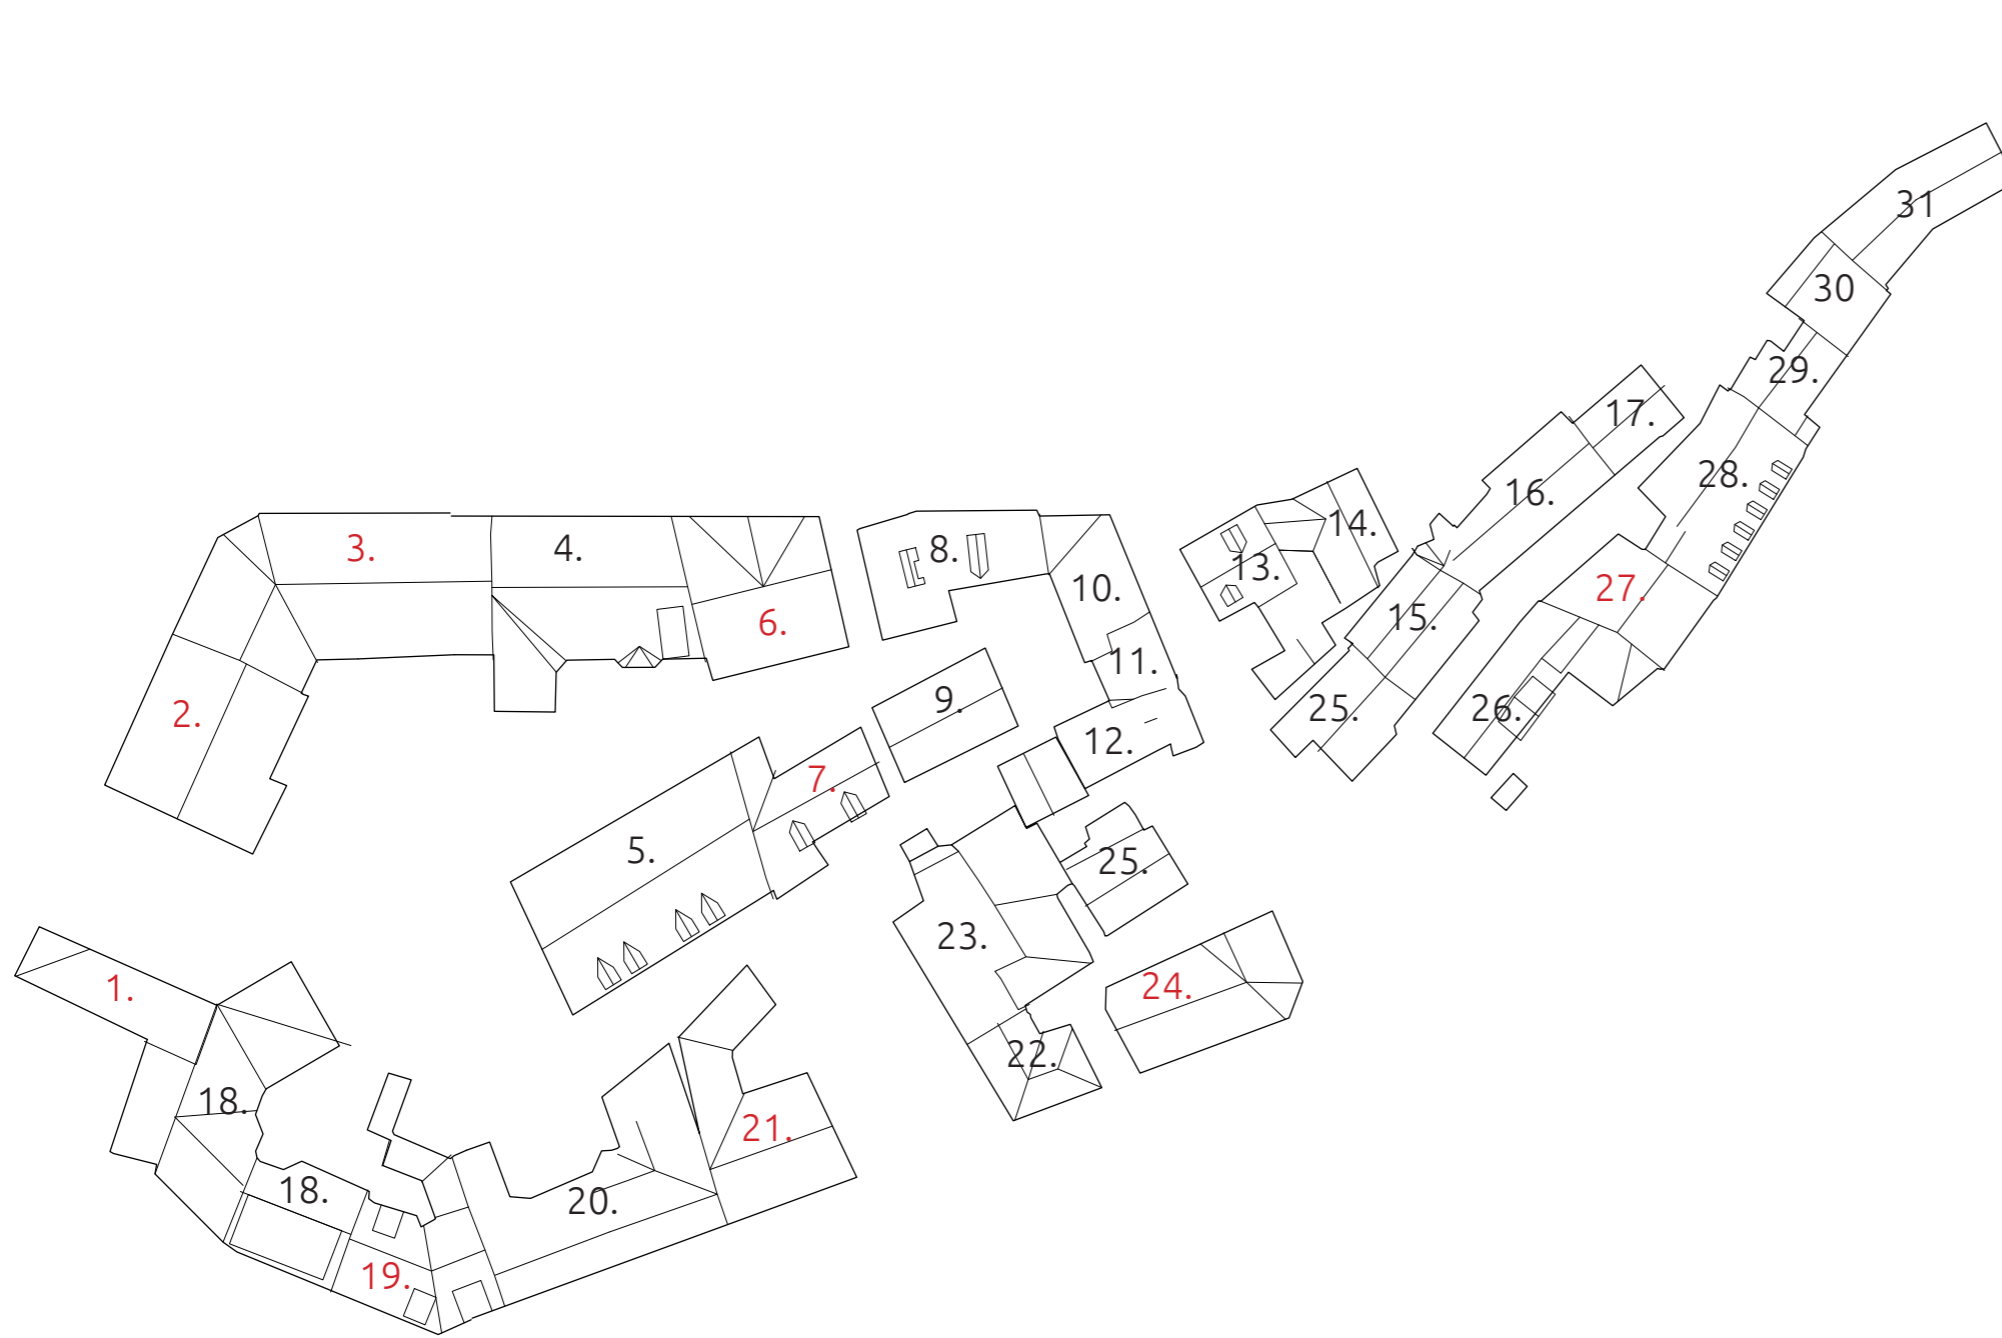
1. Akersveien 18 Bygård 1883 Office space	9. Damstredet 8 Bygård Mid 1800 Dwelling	17. Damstredet 22 Wooden house 1850 Dwelling	24. Dops gate 12 Wooden house Early 1800 Dwelling

2. Akersveien 20 Brick house 1859 Architecture office	10. Damstredet 12 Bygård 1859 Dwelling	18. Dops gate 4 Bygård 1860-1894 Dwelling	25. Fredensborgveien 28b Wooden house 1800s Dwelling

3. Damstredet 2 Bygård 1859 Dwelling Grocery shop	11. Damstredet 12B Wooden house Late 1800 Dwelling	19. Dops gate 5 Bygård 1859 Dwelling Boutique	26. Fredensborgveien 30 Wooden house 1875 Dwelling

4. Damstredet 4 Bygård 1866 Dwelling	12. Damstredet 12C Wooden house Early 1800 Dwelling	20. Dops gate 6 Bygård 1861 Dwelling	27. Fredensborgv. 30b Bygård late 1800 Dwelling Instrument shop

5. Damstredet 4 Bygård 1887? Dwelling	13. Damstredet 14 Brick house late 1800 Dwelling	21. Dops gate 7 Bygård 1859 Dwelling Dentist	28. Fredensborgv. 32 Bygård Early 1827 Dwelling

6. Damstredet 8 Brick house Mid 1800 Shared office	14. Damstredet 16 Brick house 1815 Dwelling	22. Dops gate 9 Bygård 1863 Dwelling	29. Fredensborgv. 32b House Early 1800 Dwelling

7. Damstredet 8 Bygård 1859 Dwelling Adverticing agency	15. Damstredet 18 Wooden house 1820 Dwelling	23. Dops gate 10 House Early 1800 Dwelling	30. Fredensborgv. 34 Bygård Mid 1800 Dwelling

8. Damstredet 8 Wood house Early 1800 Dwelling	16. Damstredet 20 Wooden house 1801 Dwelling	23. Dops gate 11 Bygård 1880 Dwelling Hairdresser	31. Fredensborgv. 36 Bygård Mid 1800 Dwelling

Description of buildings in area.
Red: Buildings including a public function.

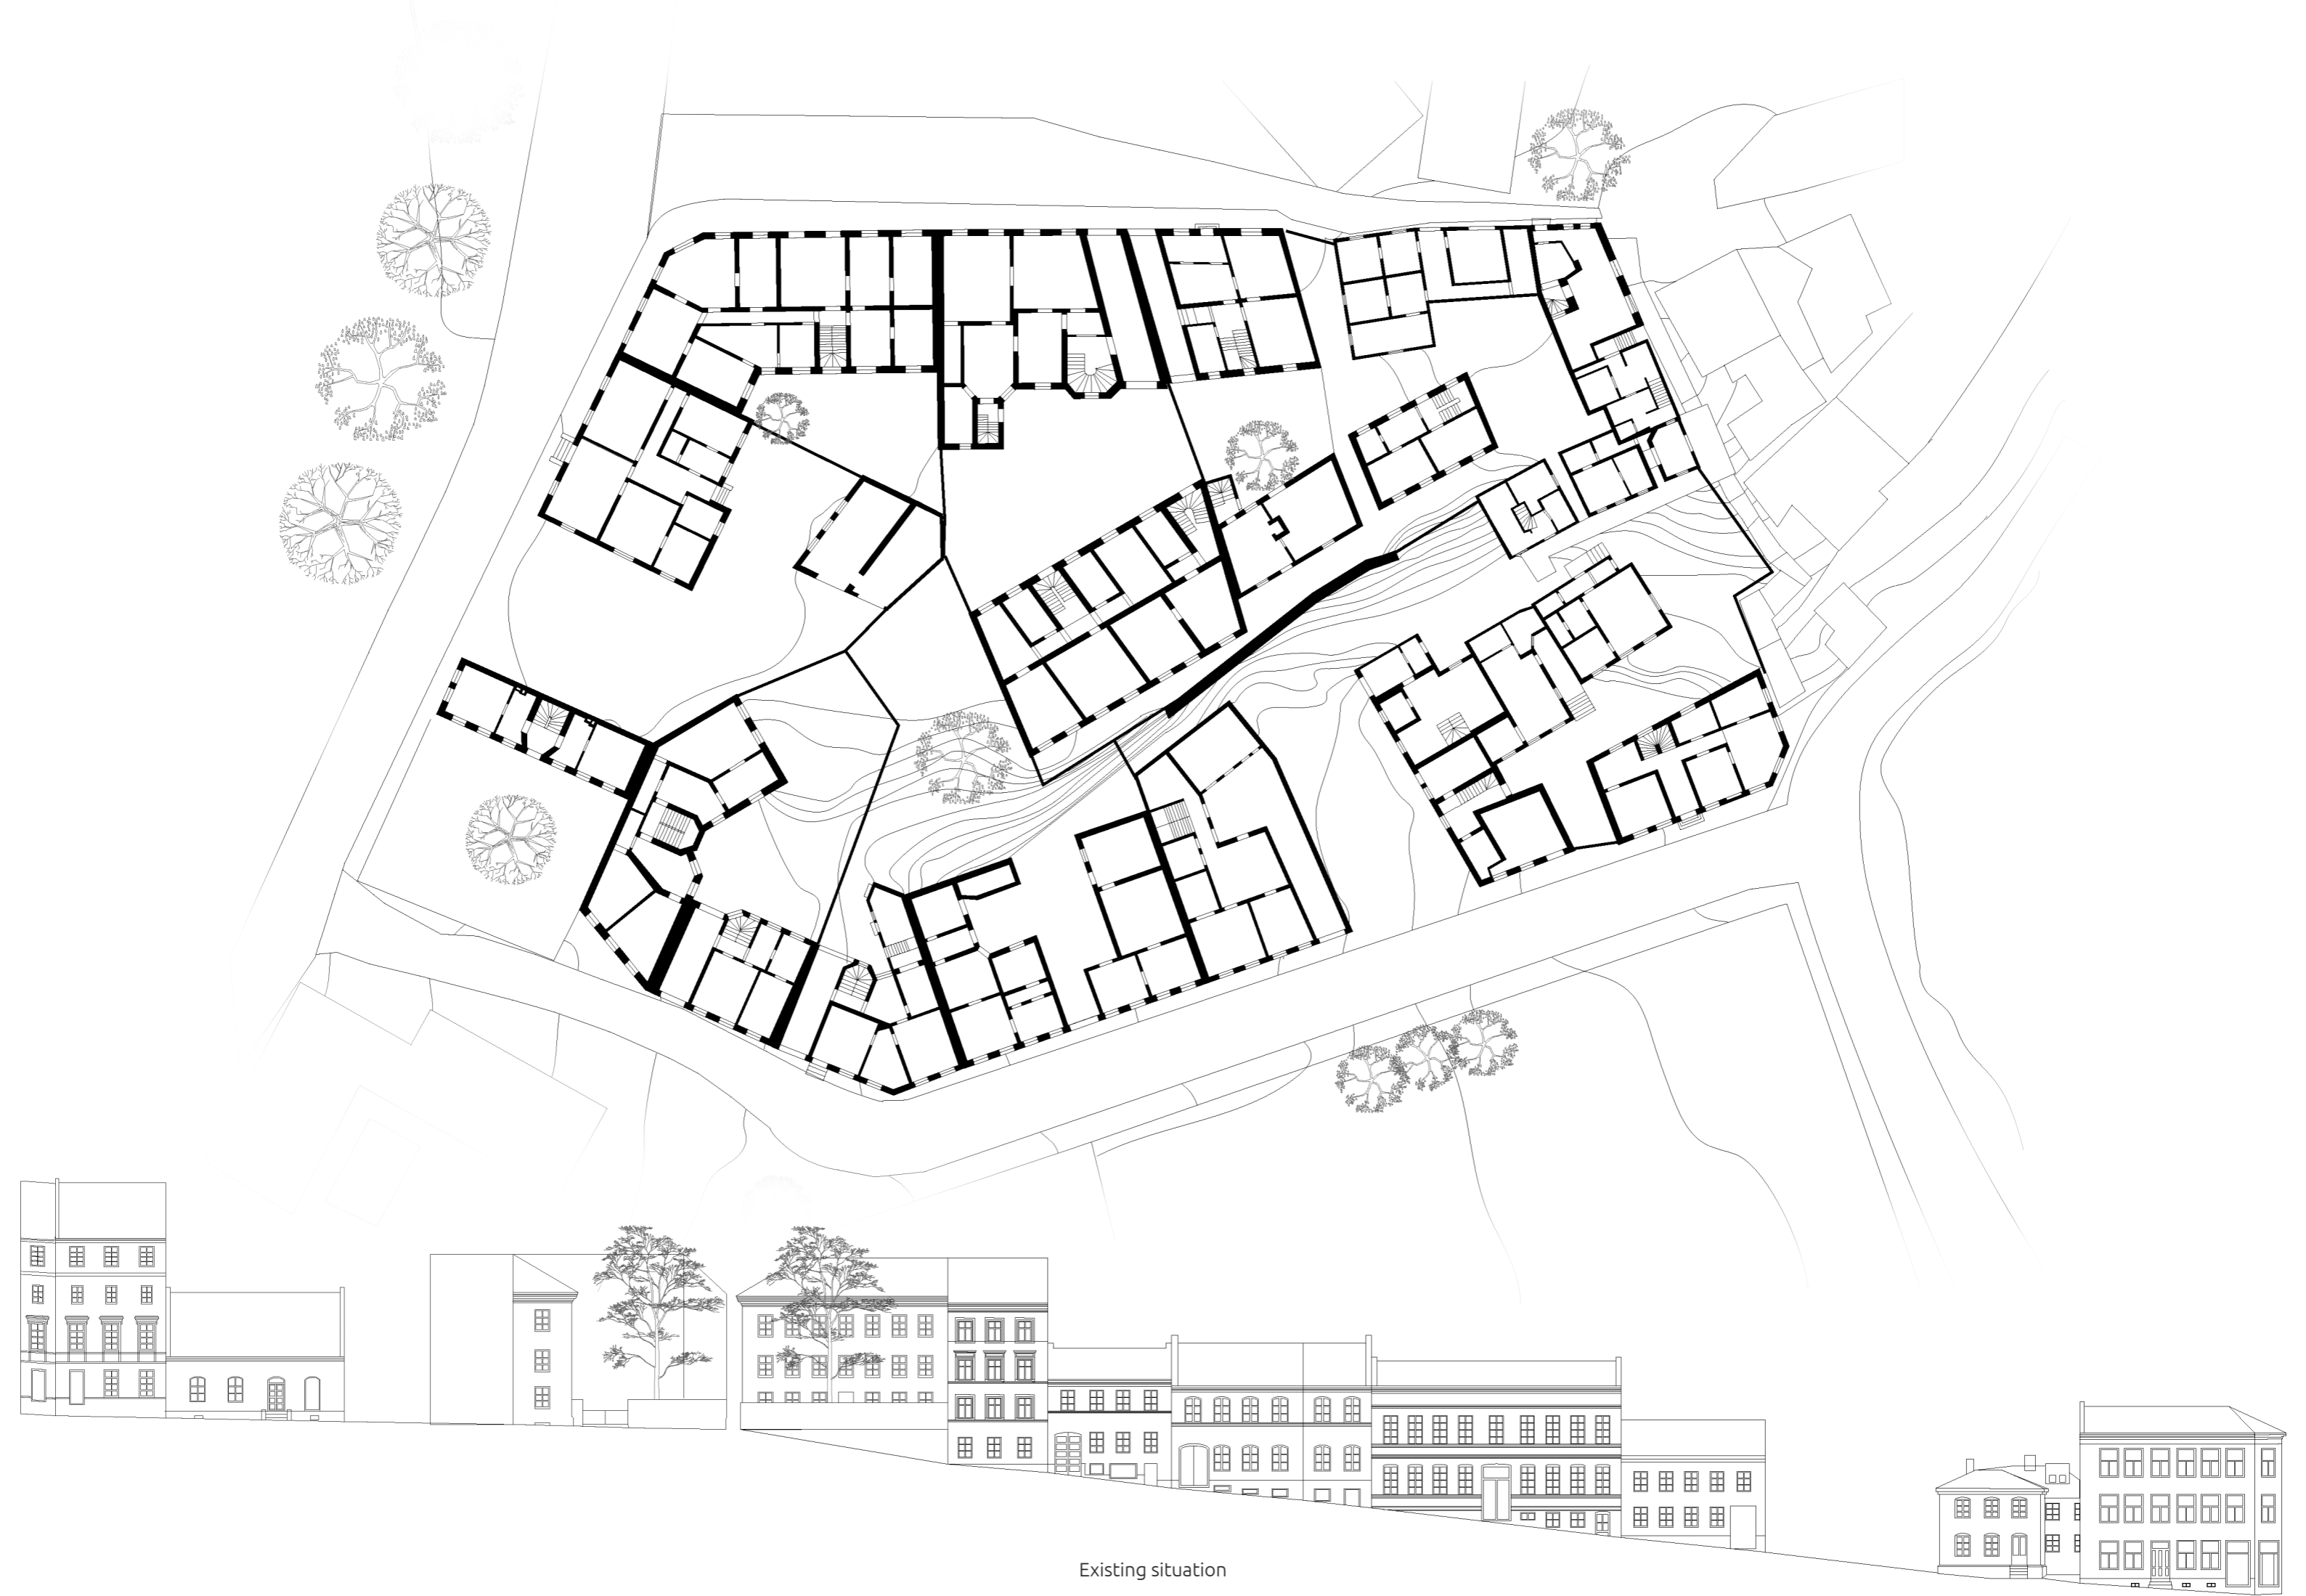
Existing situation

- Family dwellings
- Dwelling combined with studio
- Variation in experience of spaces and relation between spaces.

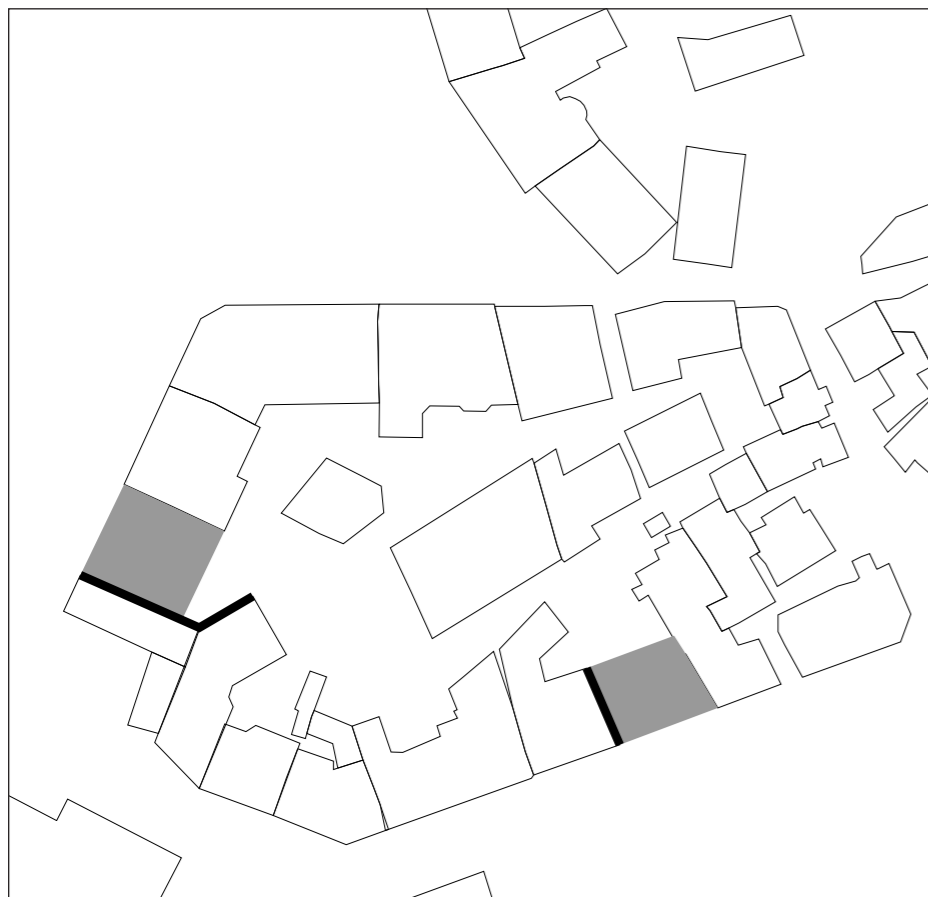
Close block by filling in empty lots

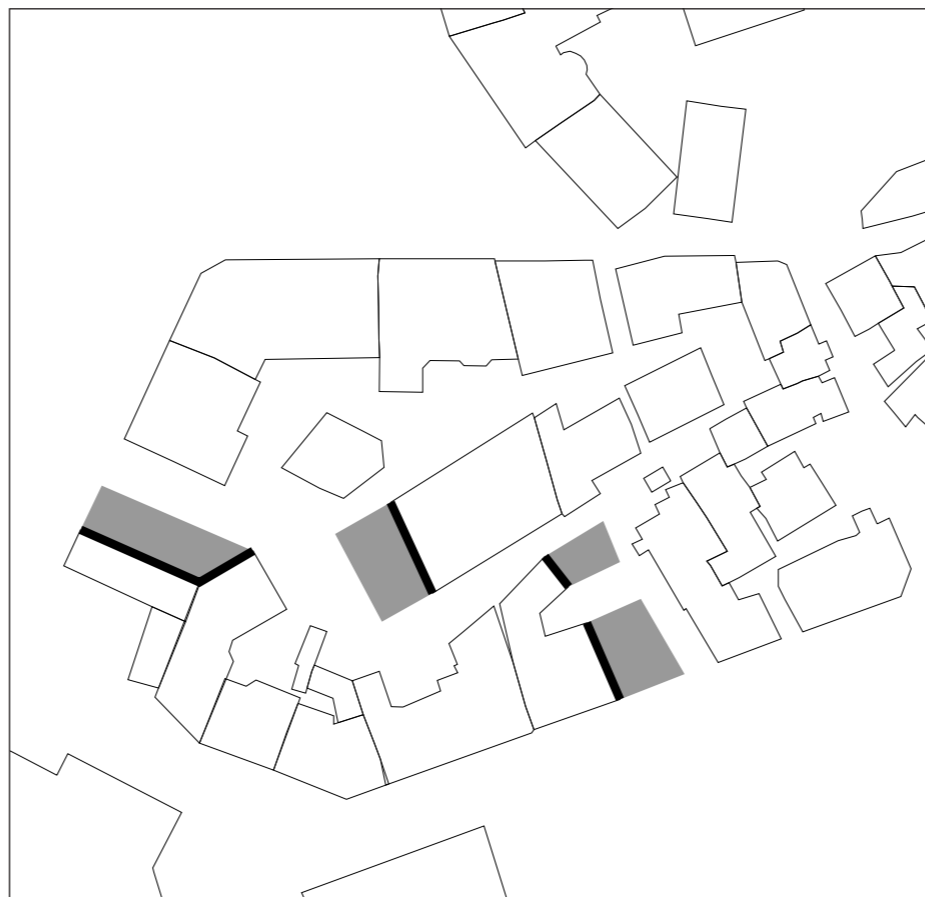
Build next to gable walls

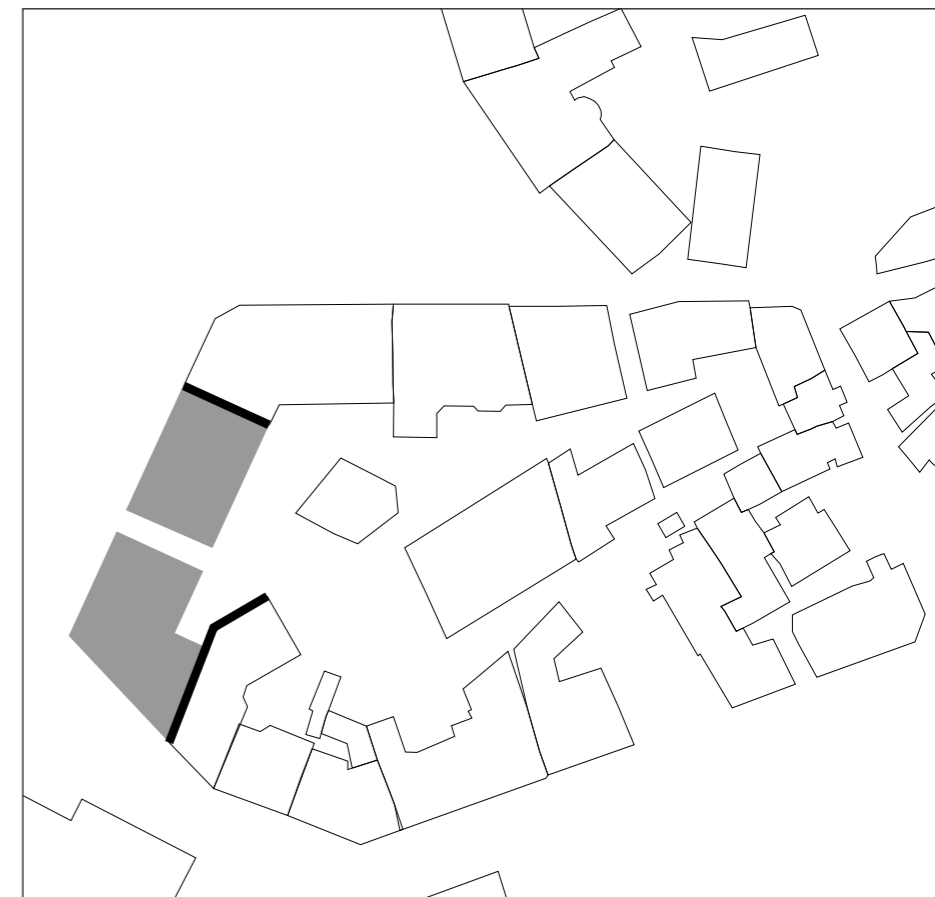
Rebuild corner

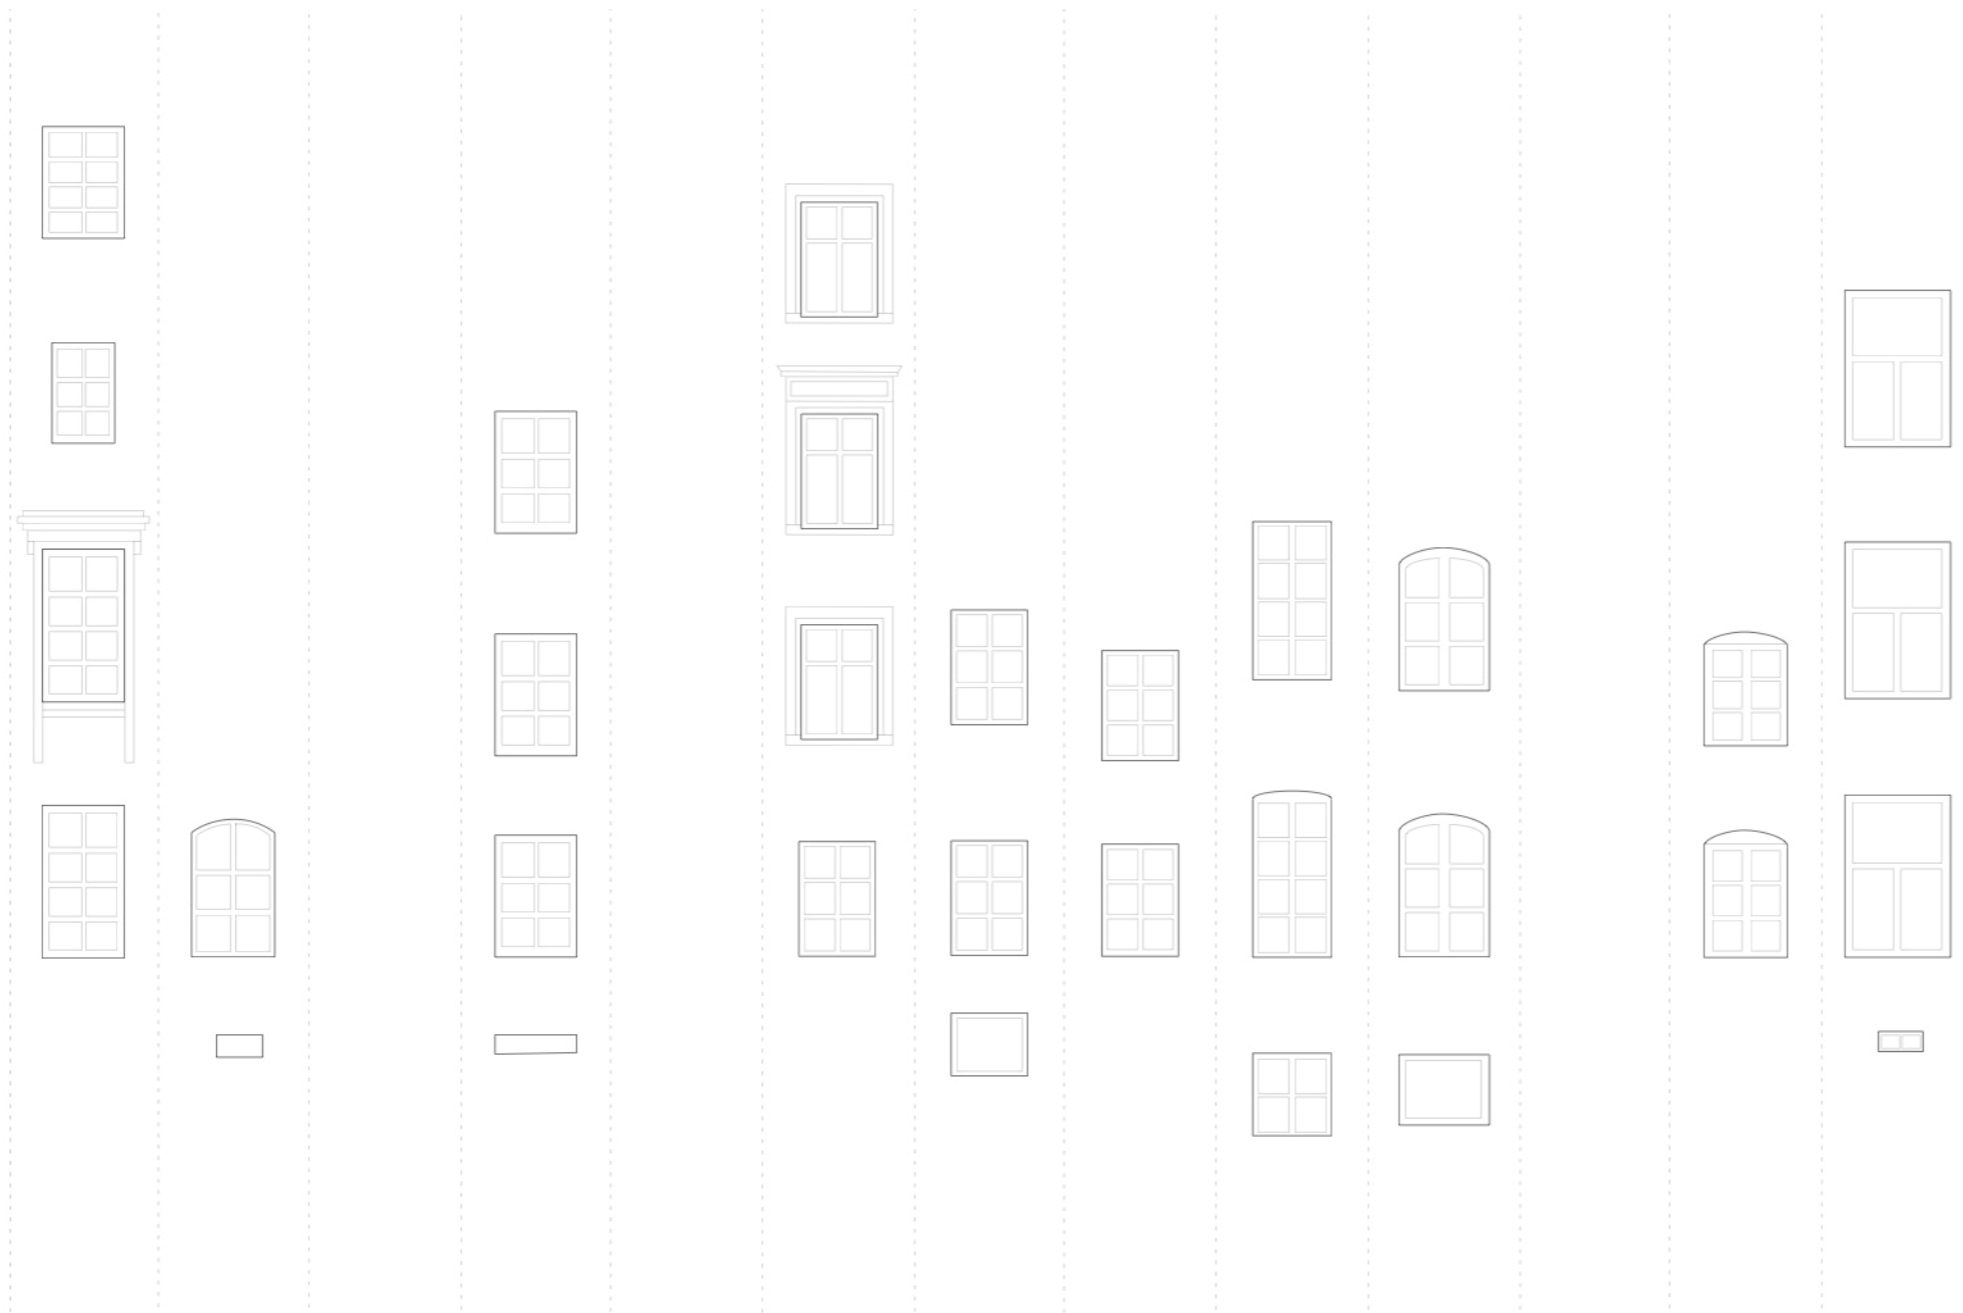
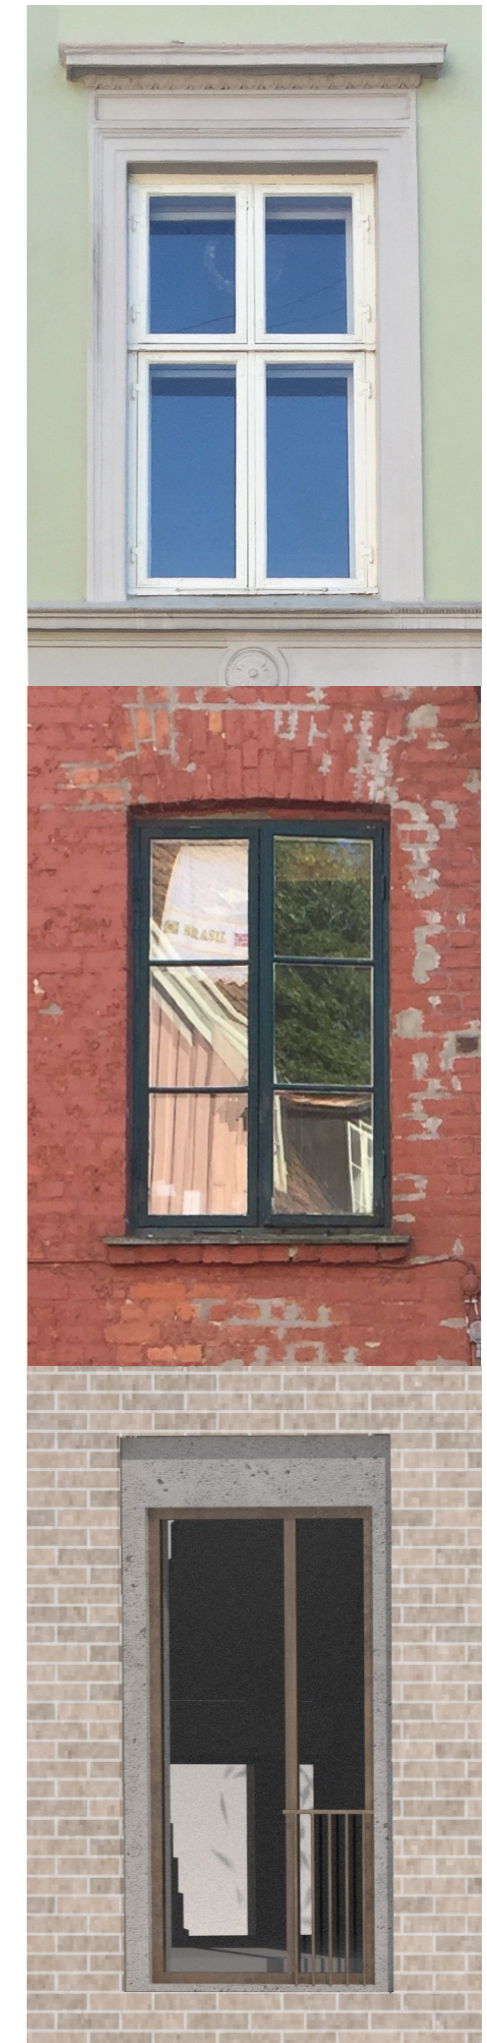
Window type and composition
 Damstredet 2 to Dops gate 12, from left

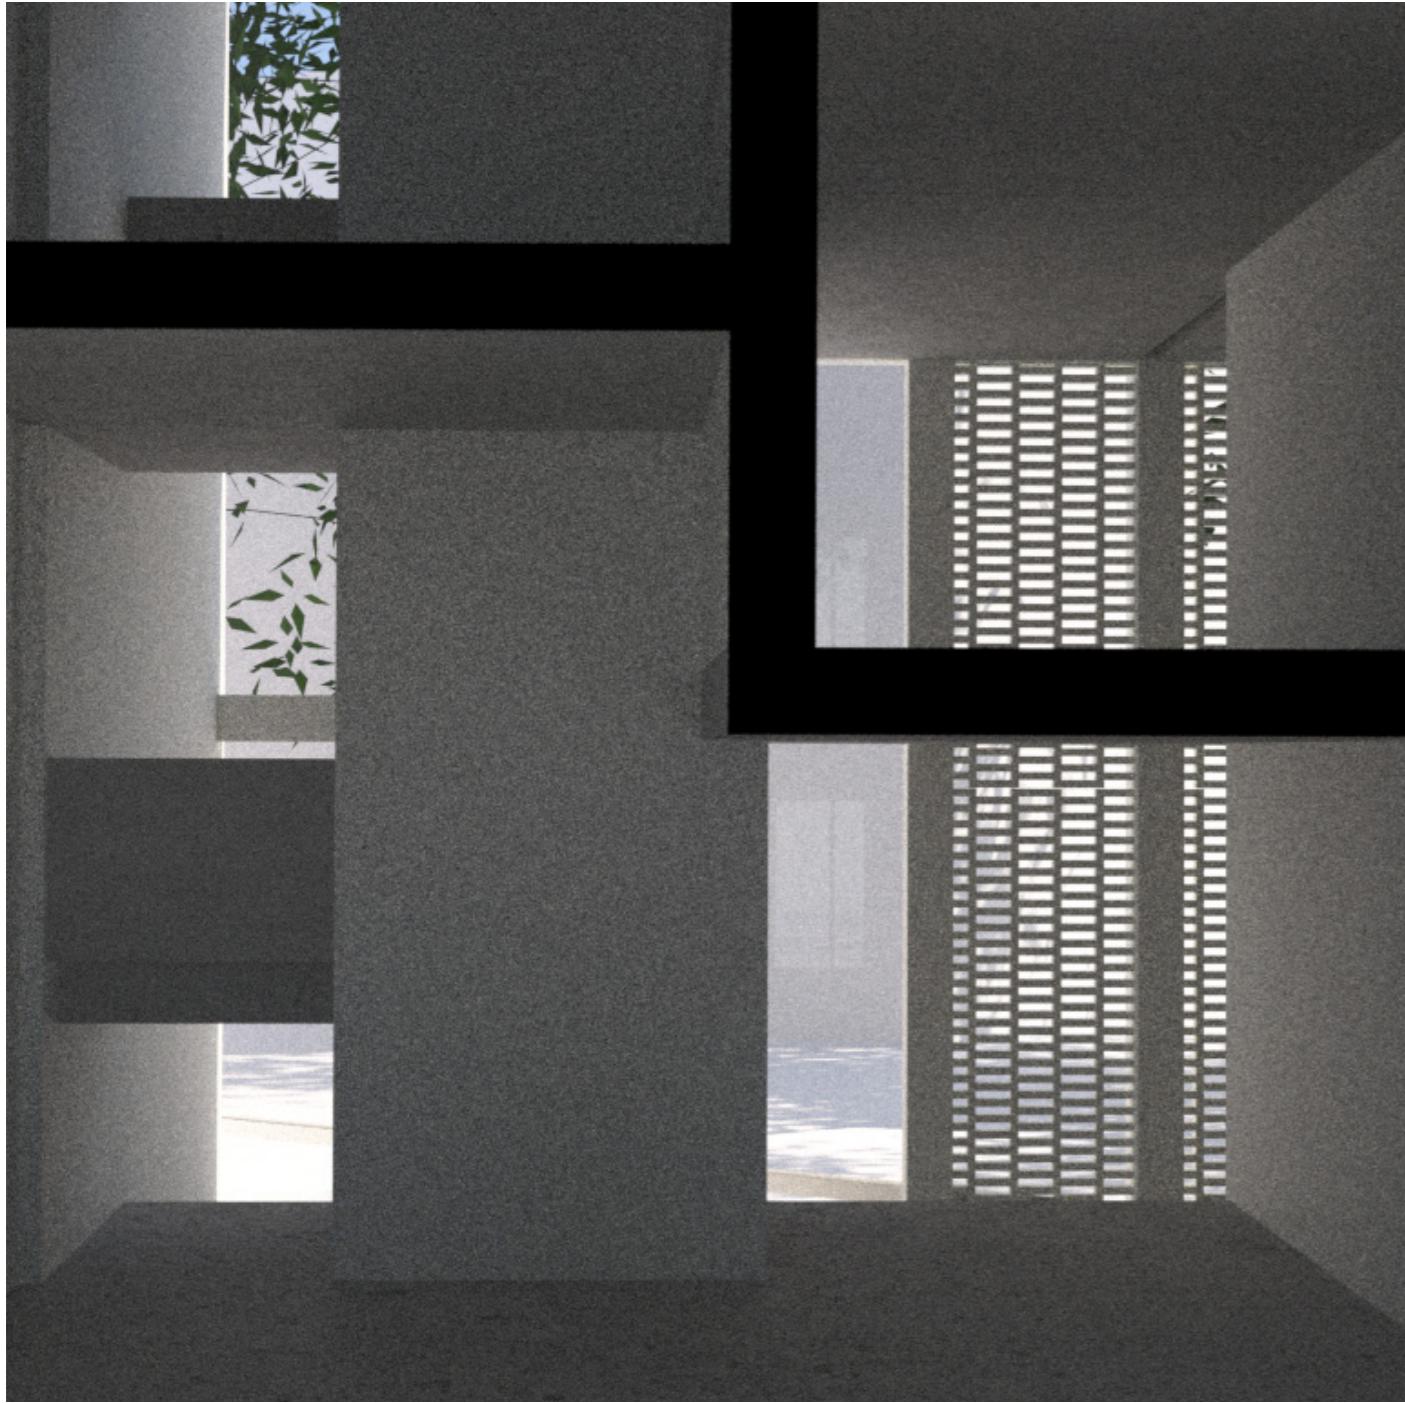
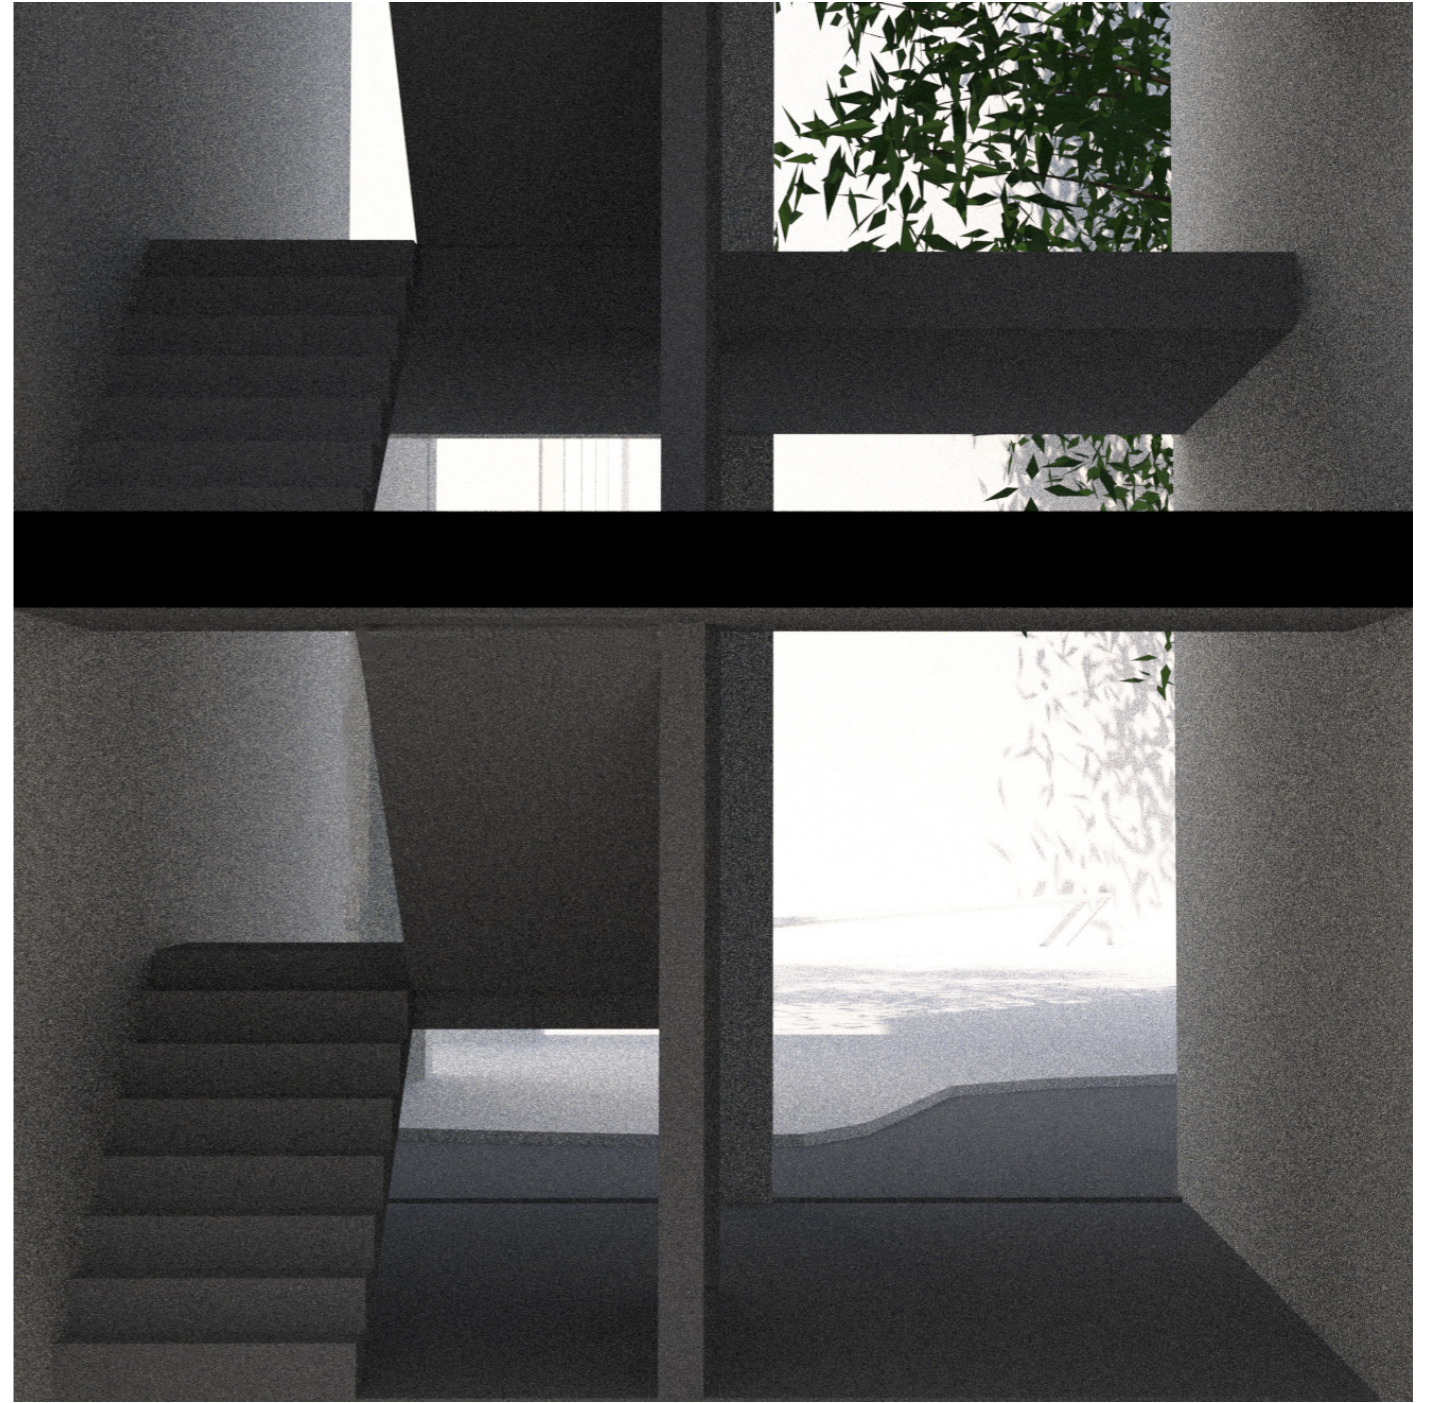
Left: Apartment house
Right: Townhouse
