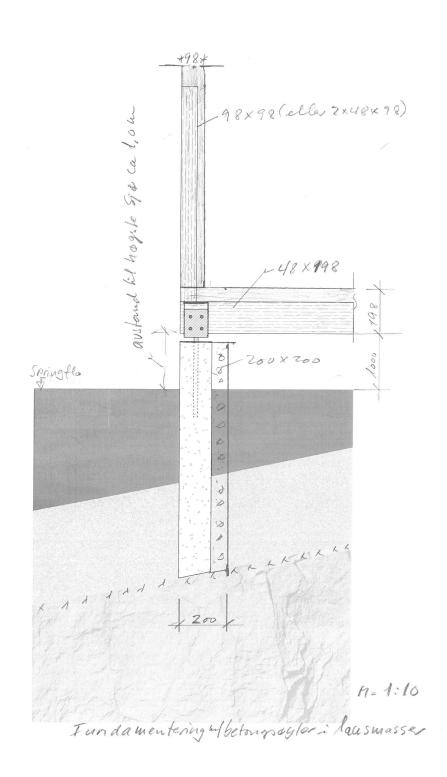
Reinforced concrete column into rocky ground

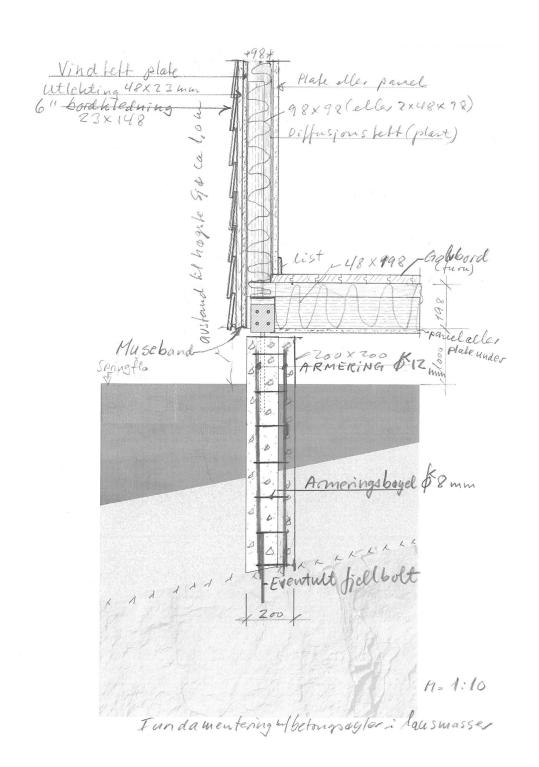
Reinforced concrete column into rocky ground with timber cladding on external walls.

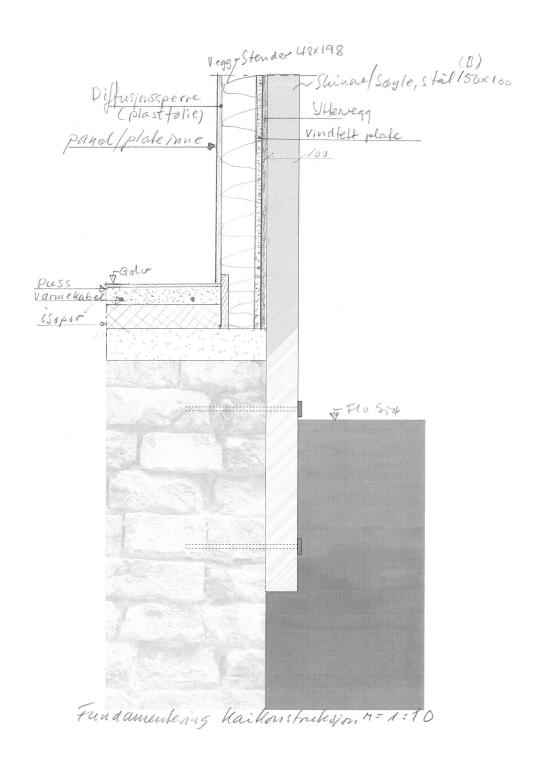
Foundation detail of cabin by the quay, steel column bolted into existing stone wall.

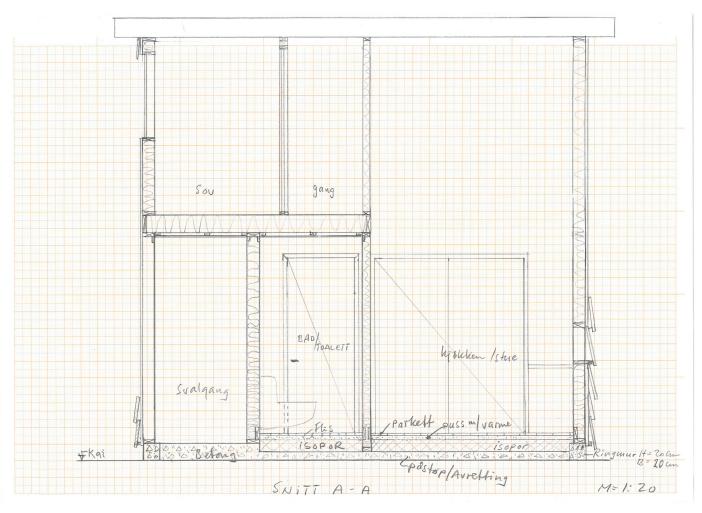
Process sketch of section through cabin by the quay, investigating insulation in wall and floor slab

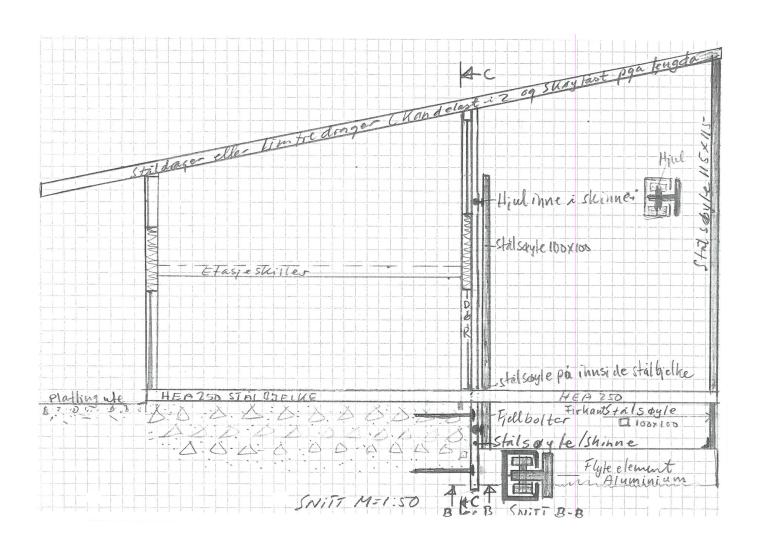
Process sketch of section through cabin by the quay, investigating using a steel beam to support cantelivering section,

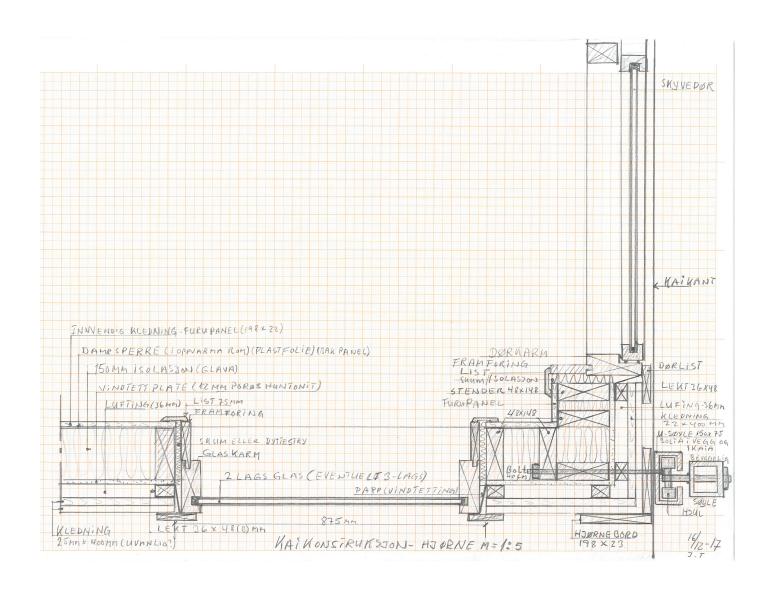
Detail of internal comer with steel column placed on the outside allowing flowating element to move within U-shaped steel column

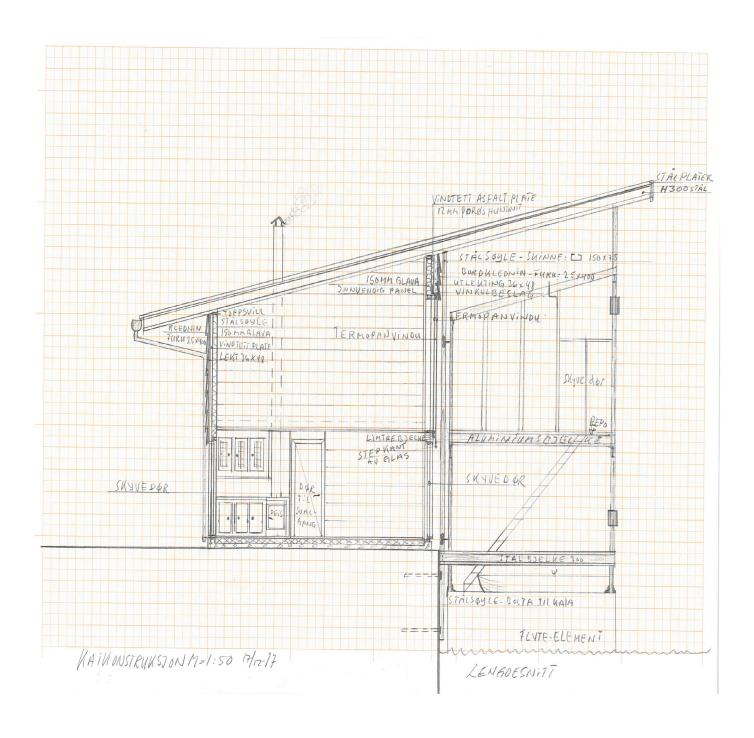
Section after making amendments with length and height of the building to allow movable floor to correspond with maximum high tide

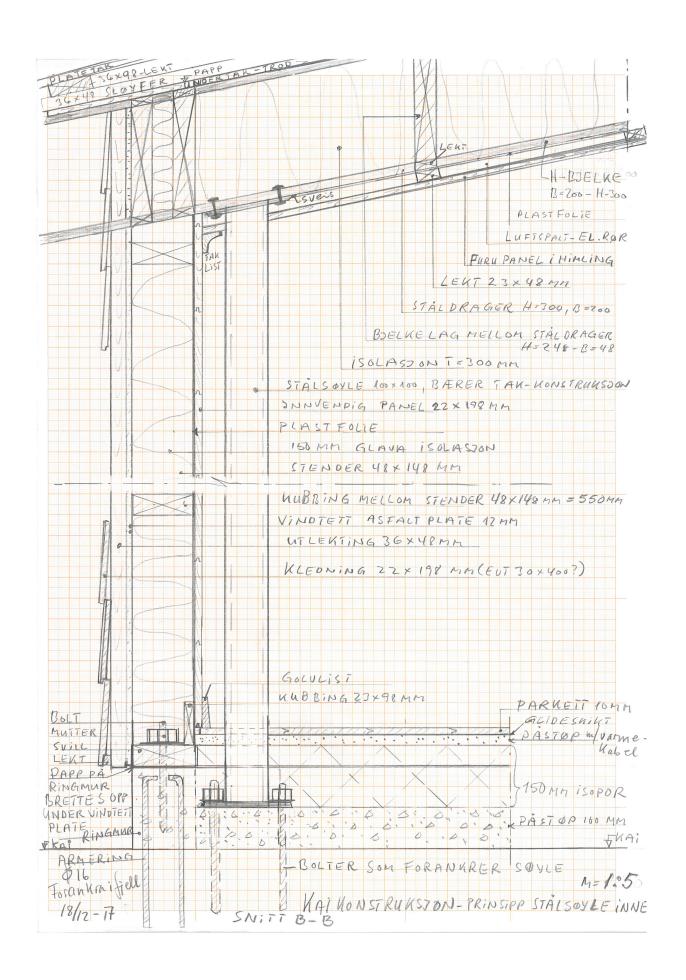
Roof detail along long section exploring gluelam beam and insultated roof and insulated external wall, exposing steel column in the inside
