Reinterpreting: Folketeateret

Five-scale model and reinterpretation

Diploma

The Oslo School of Architecture and Design

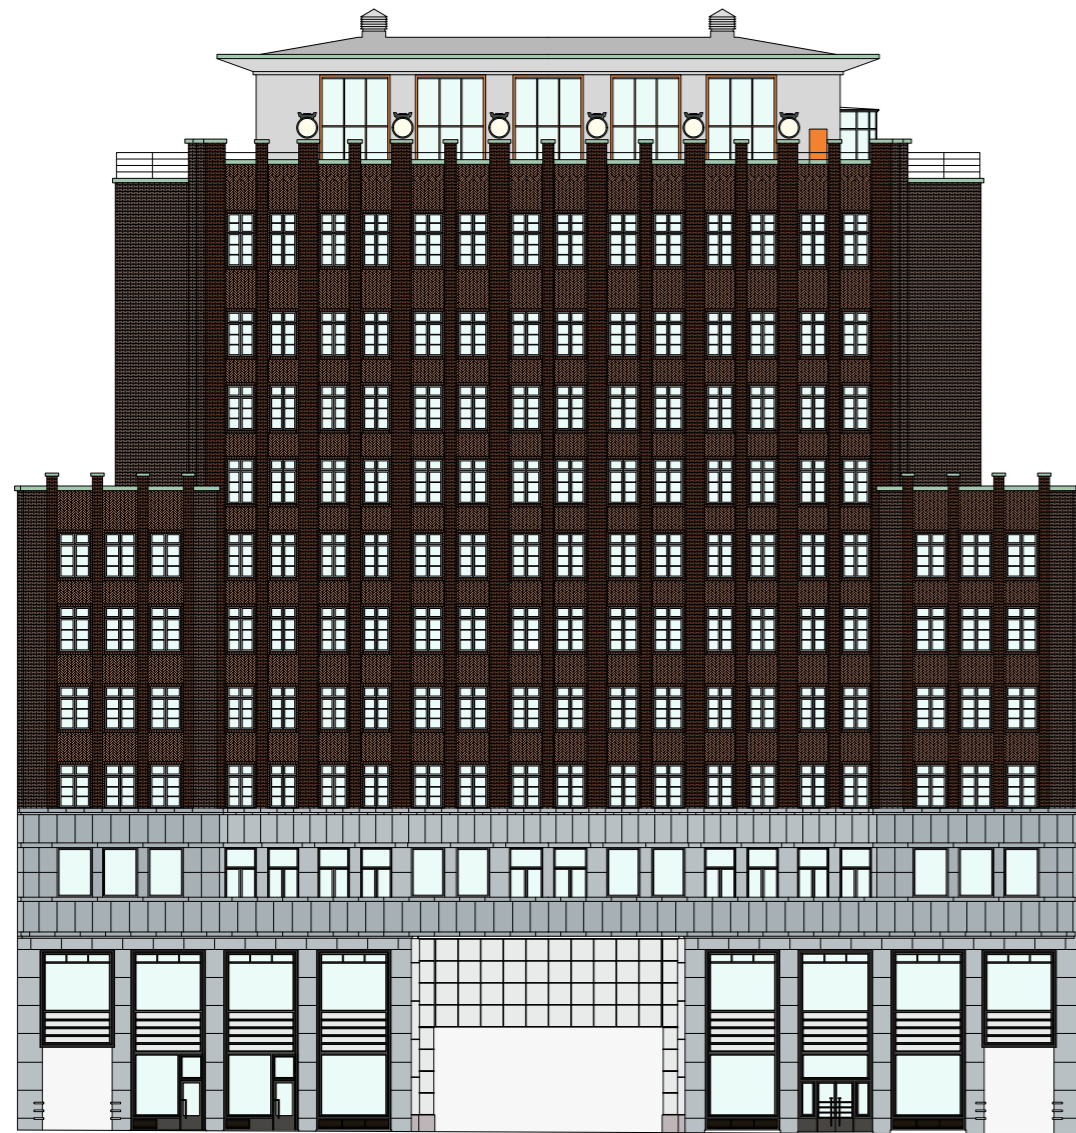
Facade, Youngstorget
 Historical, after original drawings by Morgenstjerne & Eide, 1935
 1:400/A3

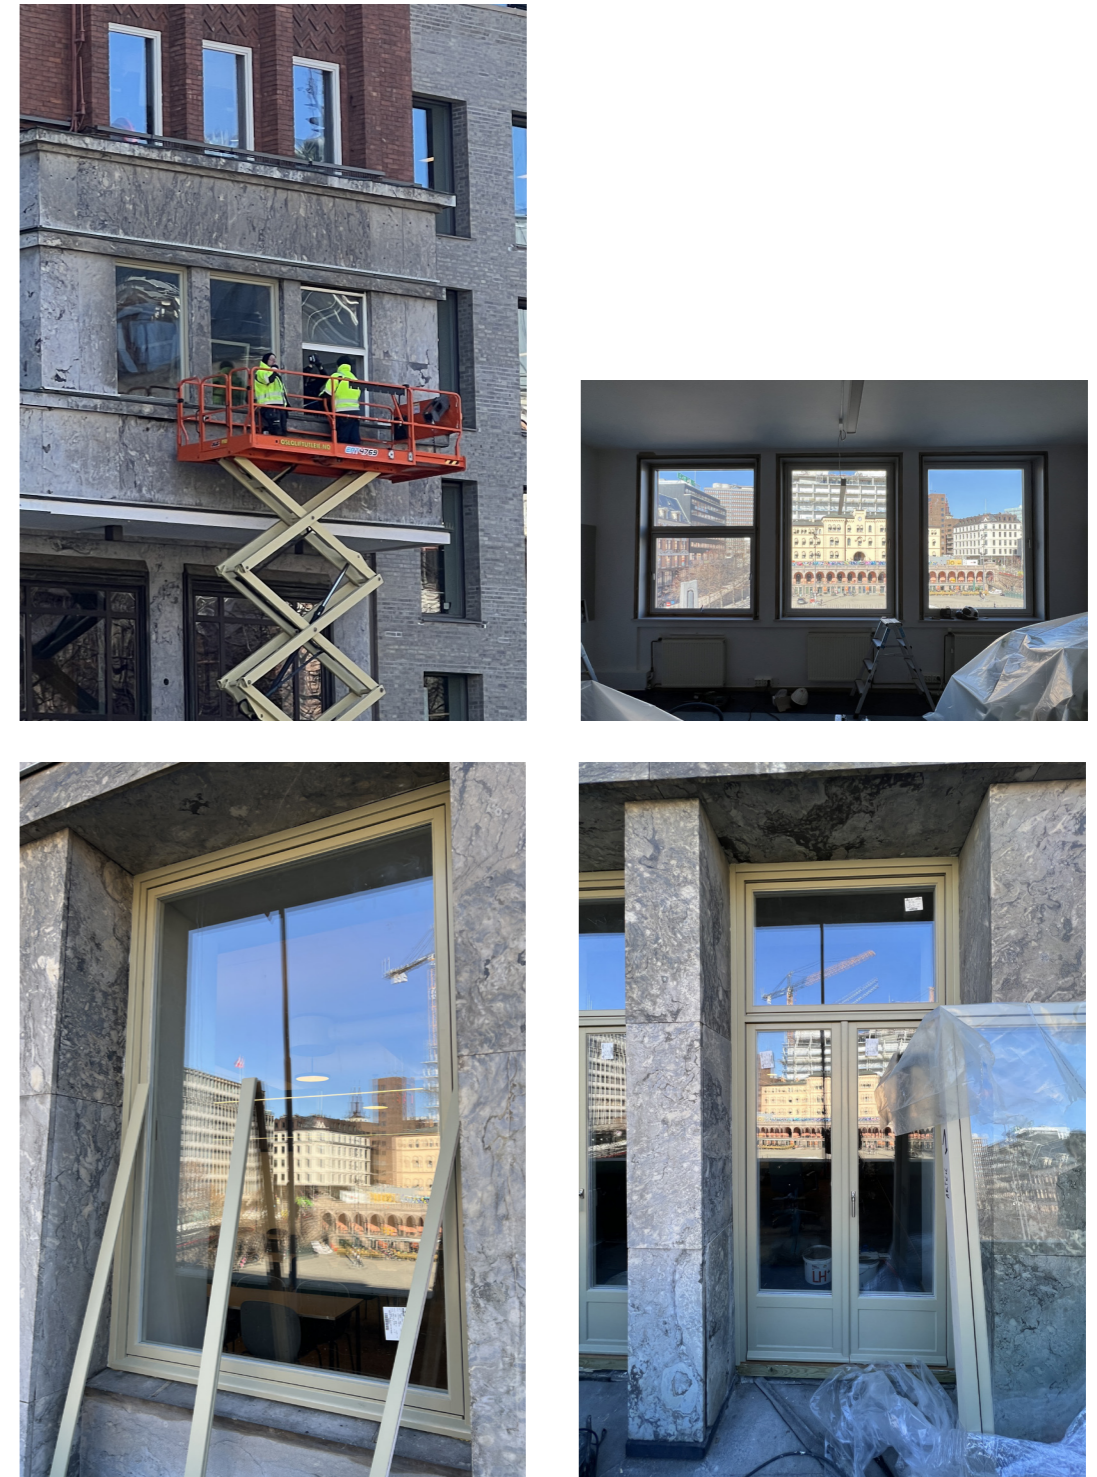
Figure 5

Site-visit to Folketeateret, Youngstorget 2.
New doors and windows on the 3rd floor.

Now, 47 years later, windows and doors are again being replaced on the third floor towards Youngstorget. (Fig.5) The listing document reveals that this operation has been anticipated by Riksantikvaren since 2009. (Fig.3b) The design for the windows and doors is based upon an extended research done by the architects at Rebuilding AS in 2021, who have worked out guidelines for reverting (“tilbakeføre”) the windows to the original design, based upon archival material (documents, photos, drawings), literature; while thoroughly cataloguing all the existing windows in the building, taking measurements, and searching for the original colour schemes.

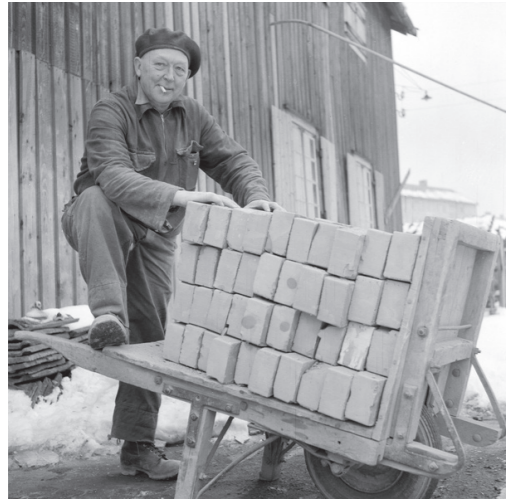
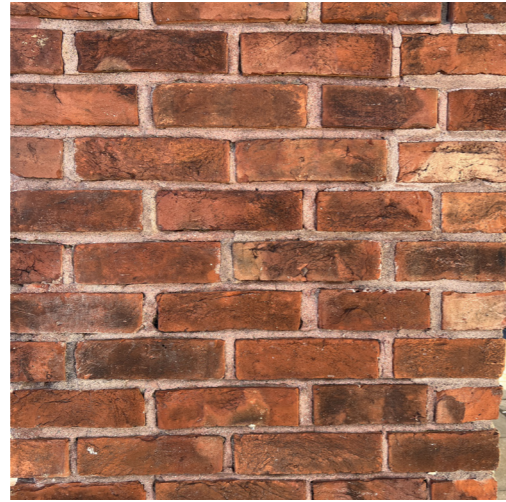
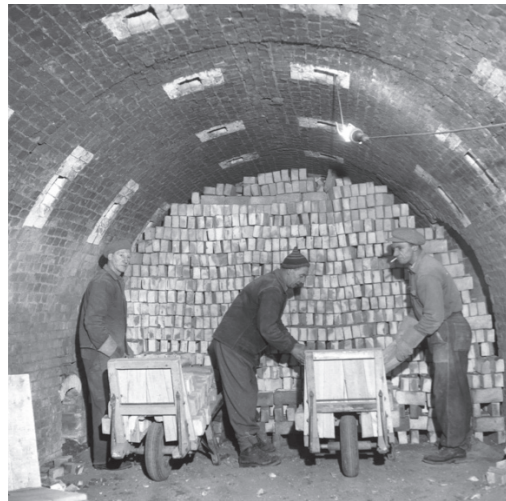
Figure 1

- Top left: Worker at Hovind Teglverk posing for Arbeiderbladet, 1957
- Top right: Brick veneer, Folketeateret
- Bottom left: Labours piling unburned brick in the ring oven, 1953
- Bottom right: Marble tile, Folketeateret

One of the significant fragments in the architectural expression of Folketeateret is brick. The brick is made of clay. It has an uneven surface of a rectangular shape, measuring 228 mm x 108mm x 62 mm (Norwegian standard). It was made at Hovind Teglverk, produced by being manually hand-stamped in moulds of steel or wood, and when shaped burned in a Hoffmann kiln. The fragment is used as the outer shell of Folketeateret.⁴ (Fig.1)

Hovind Teglverk had, since the beginning of the late 19th century, burned their bricks in a ring oven – Hoffmann kiln, a German innovation by Friedrich Hoffman, patented in 1858.⁷ (Fig.1) The bricks move through a series of chambers for

Nevertheless, in the end, it was a granite stone from Porsgrunn, “Gråstripet norsk Labrador”, delivered by A/S Norsk Labrador & Granitindustri, that ended up in Folketeateret. (Fig.1) In between, the committee decided upon a stone from Den Ankerske Marmorforretning, “Småmønstret Breche”, but because of a cost difference, architect Eide’s preference was voted down in the committee meeting on 4th January 1934:

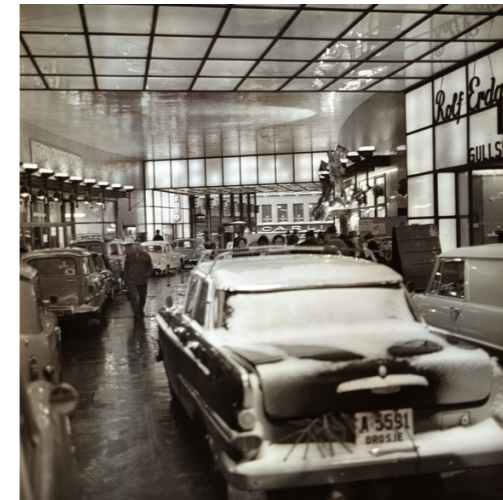
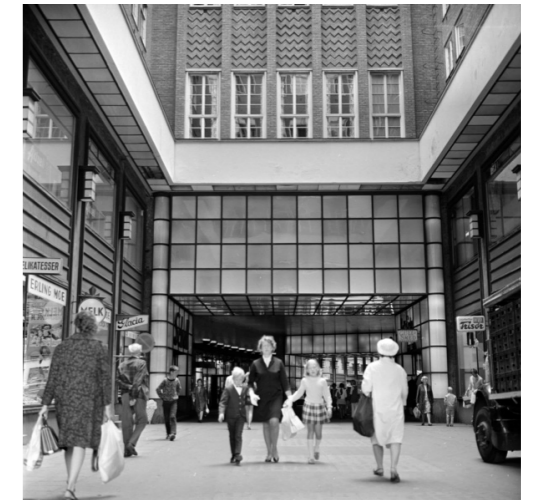
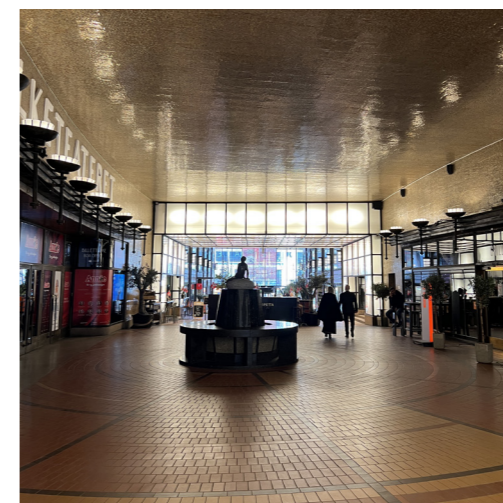
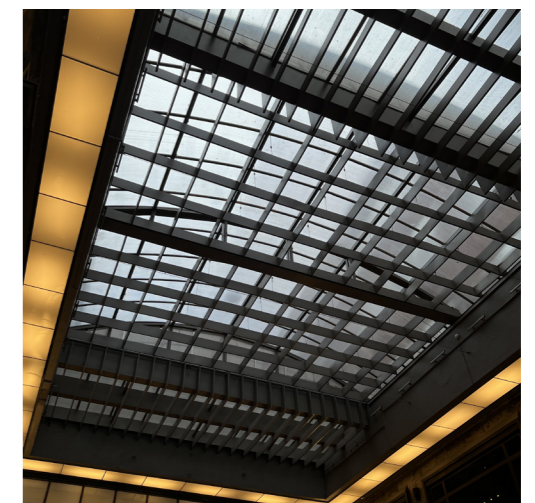
Figure 4

- Top left: Cars and pedestrians sharing the passage.
- Top right: The open atrium.
- Middle: Plan of the closed passage.
- Bottom left: The central square of the passage.
- Bottom right: Roof in the atrium, towards Storgata

The passage was a shared street between cars and pedestrians. (Fig.4)

The spatial character of the passage has changed throughout the building's history. It was built as an exterior space functioning as a public street owned by the municipality. Two atriums opened between the office buildings and the theatre, bringing in daylight.

In the 80s, the perception of what the passage was and could be had changed. On each side, the architects Dyrø-Endersen-Grevskott Larsen A/S added two concrete portals with glass façades, and the passage was furnished for pedestrians with flower boxes and benches and repaved with clinker tiles. Vans, delivering goods to the shops could enter and park, but the street was no longer a thoroughfare for cars. The passage was initially still an unacclimatised space with open atriums, but soon after, two steel and glass roofs closed off the atriums. The passage's character and spatial composition were adjusted for different use. Why the stakeholders saw the need to close off the passage is not stated; potentially, it

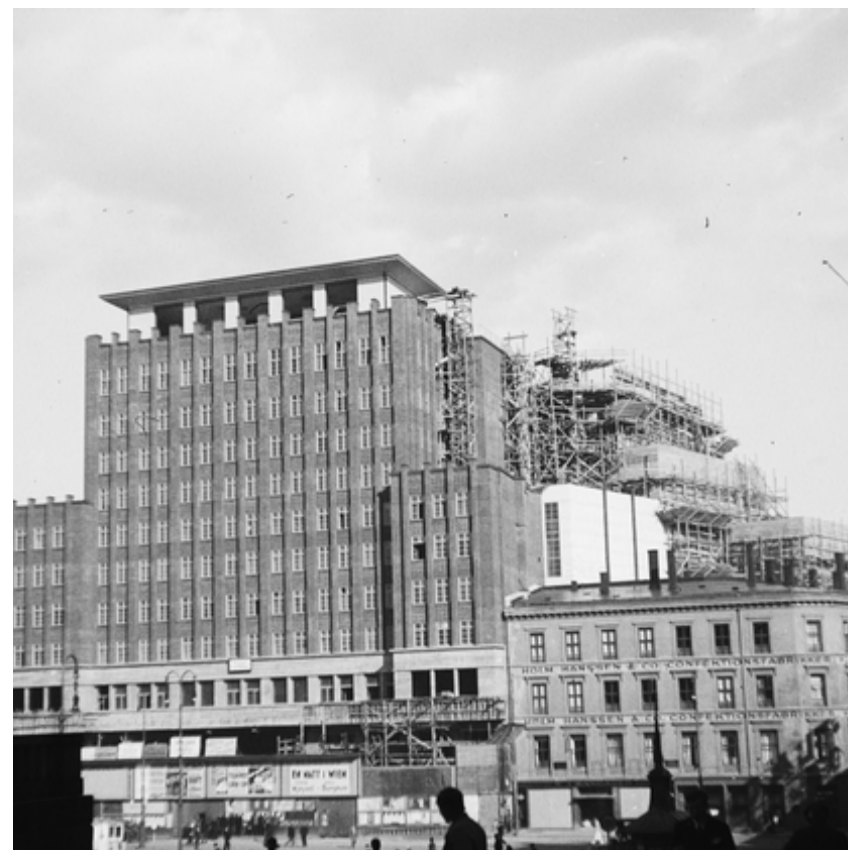
Framework to Youngstorget 2 finished, and construction the theatre's framework
1934

The construction was reinforced with iron poles ranging from 20 to 32 meters long to accommodate the varying size and height of the volumes - balancing the weight. These poles were inserted into pipes, which later were filled with concrete to anchor the structure to the bedrock. The office building facing Youngstorget was erected using an iron skeleton with infills of reinforced concrete. The other two volumes are primarily constructed using reinforced concrete, except for the theatre salon, which is situated above the passage and supported by iron beams measuring about 1 meter height.

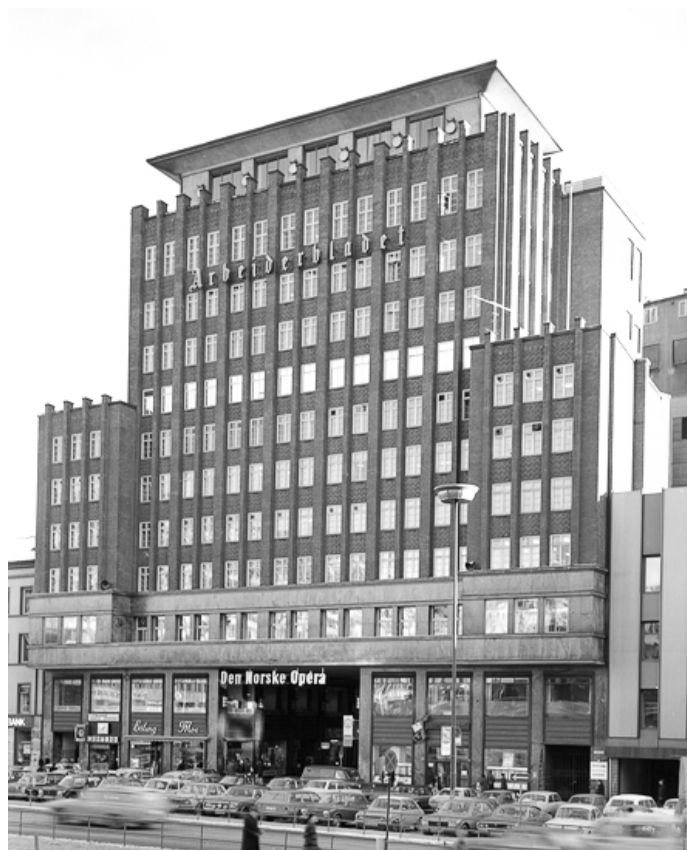
Right before new windows (3rd-11th floor)
1976

In the 1970s, the owners Andelsselskapet Folketeaterbygningen needed to upgrade the technical standard of the building, to keep down energy costs.²² The oil crisis in 1973-74 had quadruplicated the prices for raw oil in the following years. The oil burner, heating Folketeateret, had become too expensive. In 1976, Andelsselskapet Folketeaterbygningen applied for new windows of the type Nor-Dan, two-way swing windows in pressure-impregnated wooden frames with two to three layers of glass, to replace the worn-down windows in the façade towards Youngstorget. The design was without window bars. Architects – representatives in Plan- og fasaderådet (Council for plan and facades), Norske Arkitekters Landsforbund (National Association of Norwegian Architects), and Fortidsminneforeningen (National Trust of Norway) opposed the change because the design of the new windows would alter the building’s architectural expression. (Fig.4) The account given by Egil Helle in *En høyborg for kultur og politikk* explains that Norske Arkitekters Landsforbund referred to Åndsverksloven §48, and Fortidsminneforeningen termed Folketeateret *kulturminne* (a cultural heritage object), removing the bars was an act of performing “violence” to the building.²³ The appeal body, Oslo Municipality and Fylkesmannen (the county governor) disagreed upon the term *cultural heritage object* being used on a building of this age. Fortidsminneforeningen sent the complaint to Kommunaldepartementet (the Ministry of Local Government), which in 1977 stated that Fortidsminneforeningen had the legal right to oppose the alteration by claiming that Folketeateret had cultural significance, because according to the Ministry “kulturminne” was a term

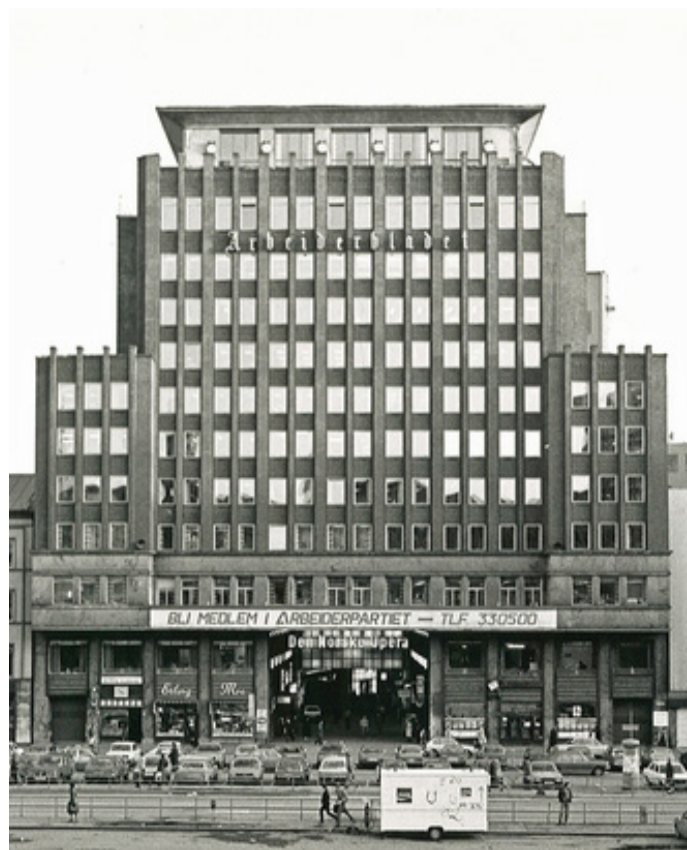
Right before closing of the passage and new windows (2nd floor)
1985
