# Renew

## Urban Mining

The Oslo School of  
Architecture and Design

*Autumn 2020*

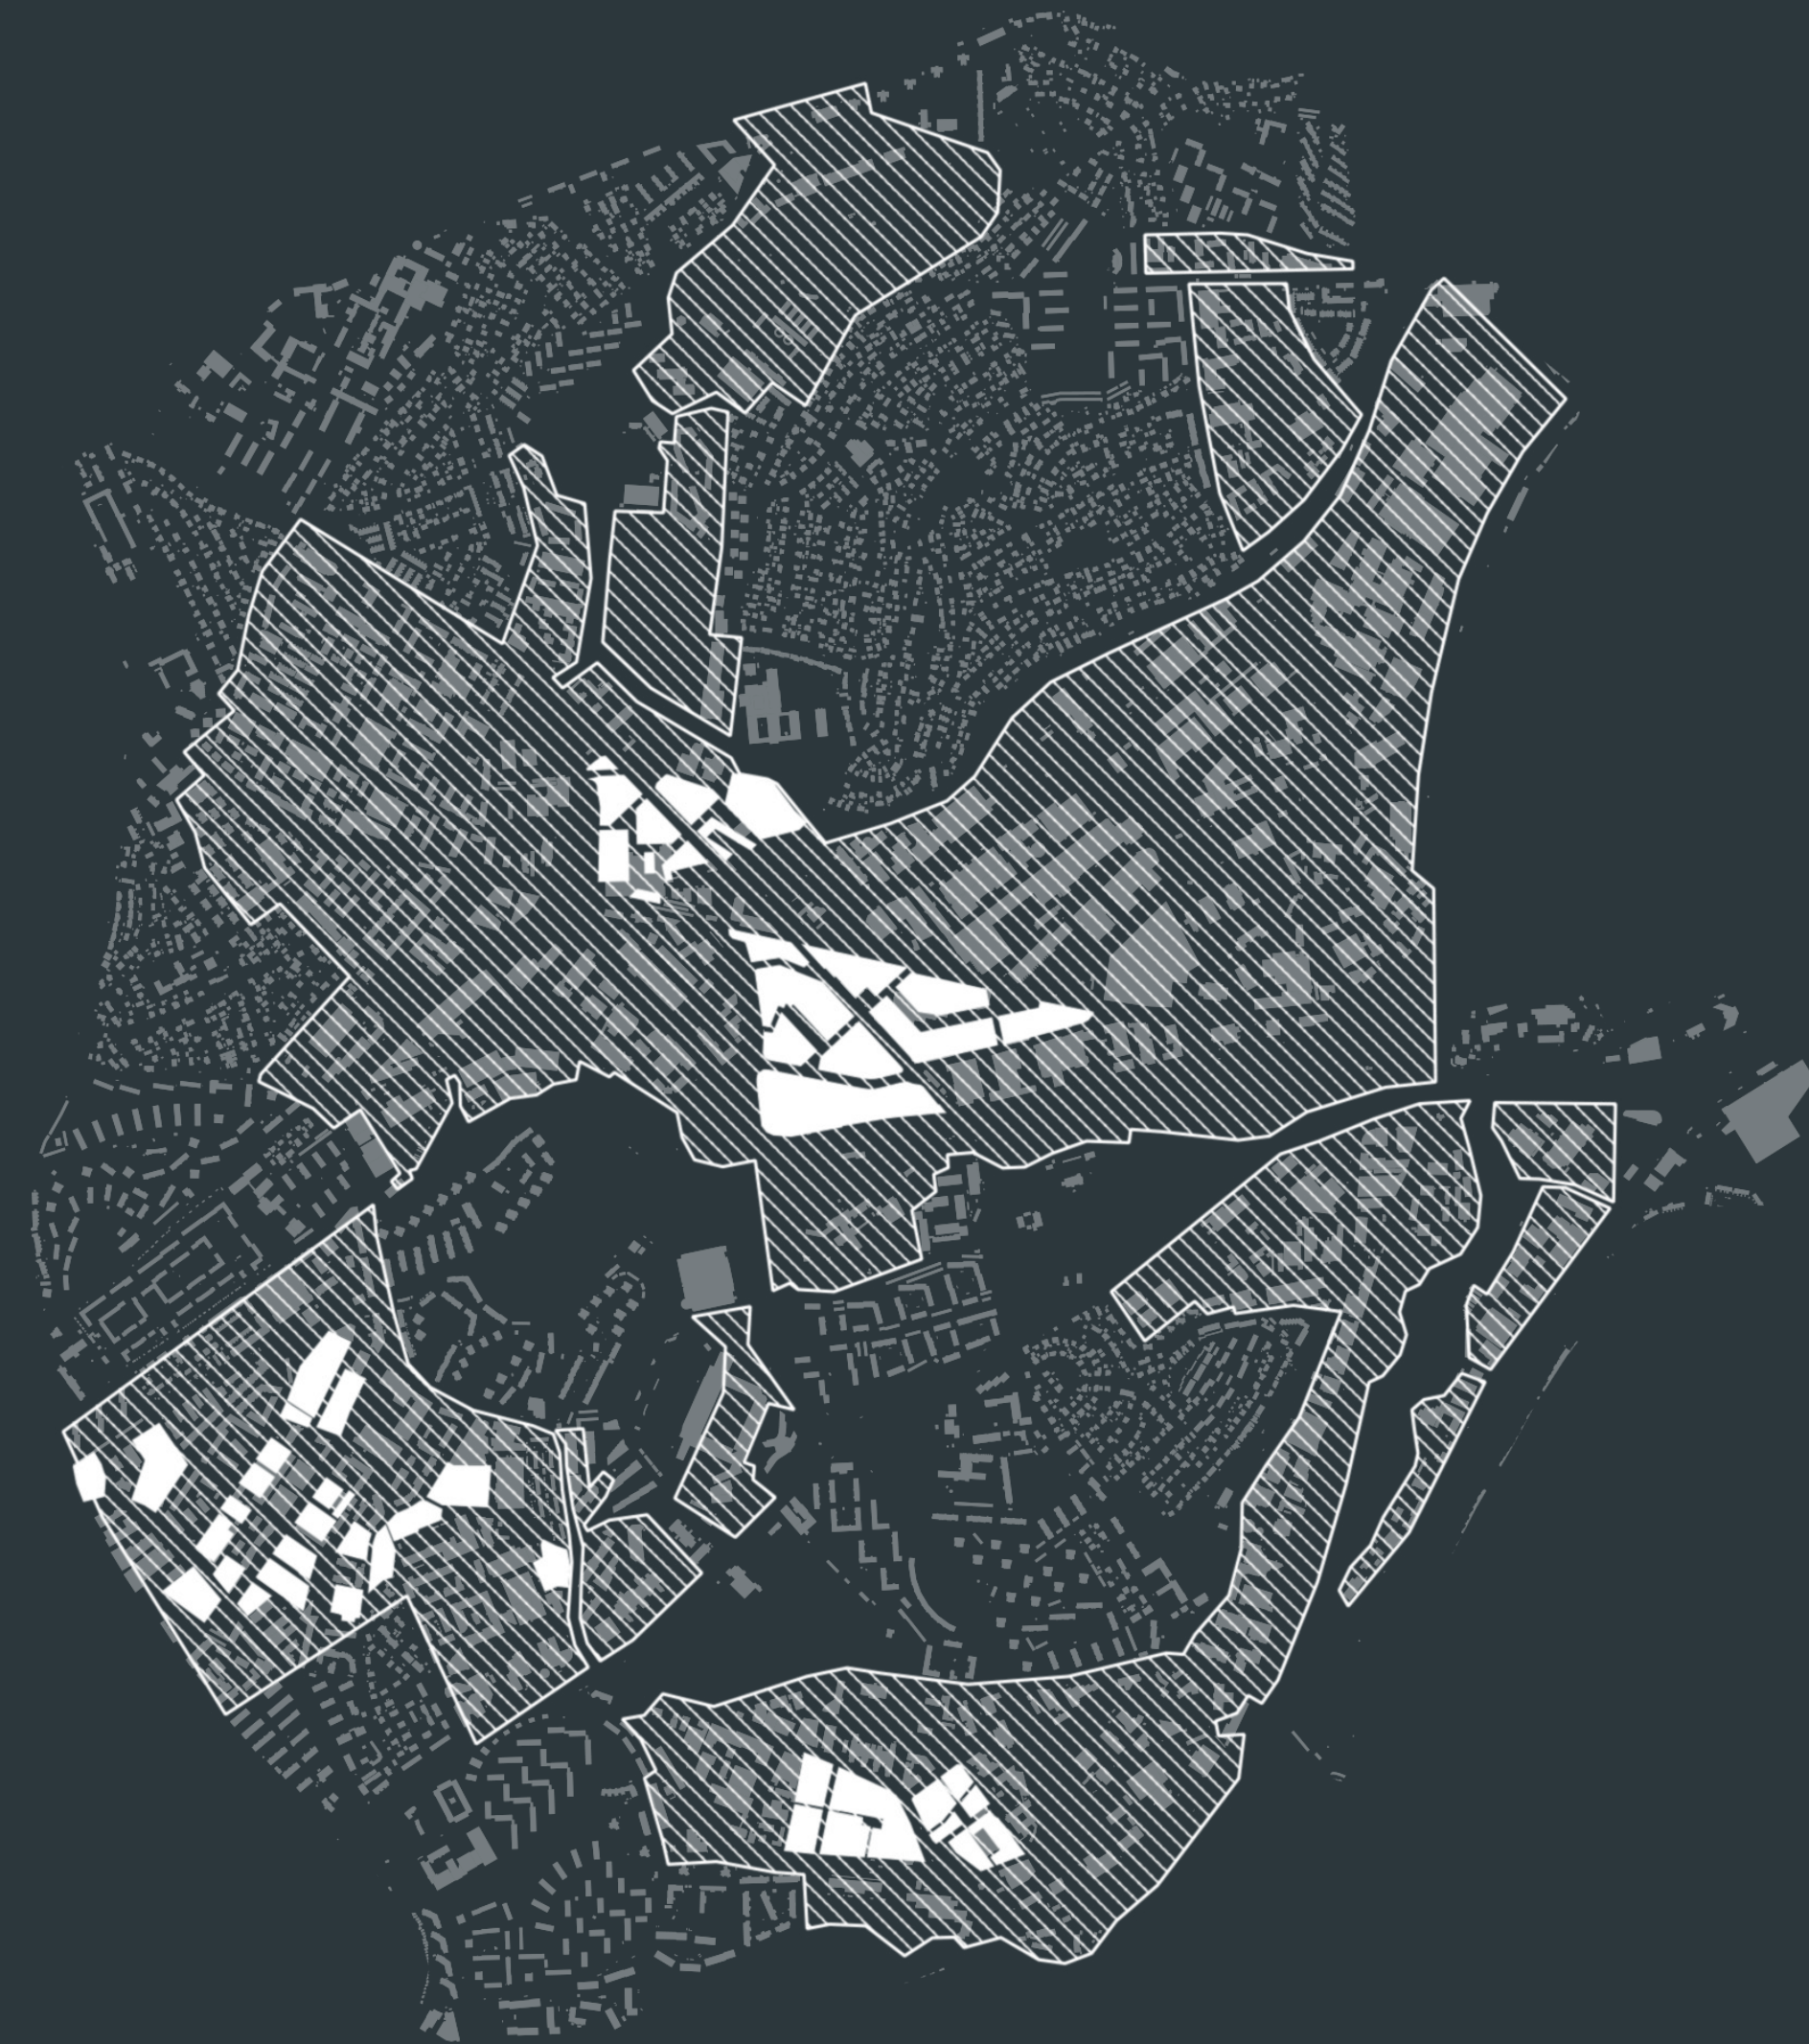
### *Development Atlas*

The map to the left illustrates the zones of development the Oslo Municipality has delineated. Individual plots have been emphasized by the author showing sites where the process has progressed to the point of concrete planning applications (as of Autumn 2020). As the planning process progresses, this atlas will become outdated. However, within the scope of this project, it points in the direction of building stock that is likely to be made available through demolition in the near future.

03. *Hovinbyen, development zones*  
Reproduced by author with GIS-data and information from a various planning applications

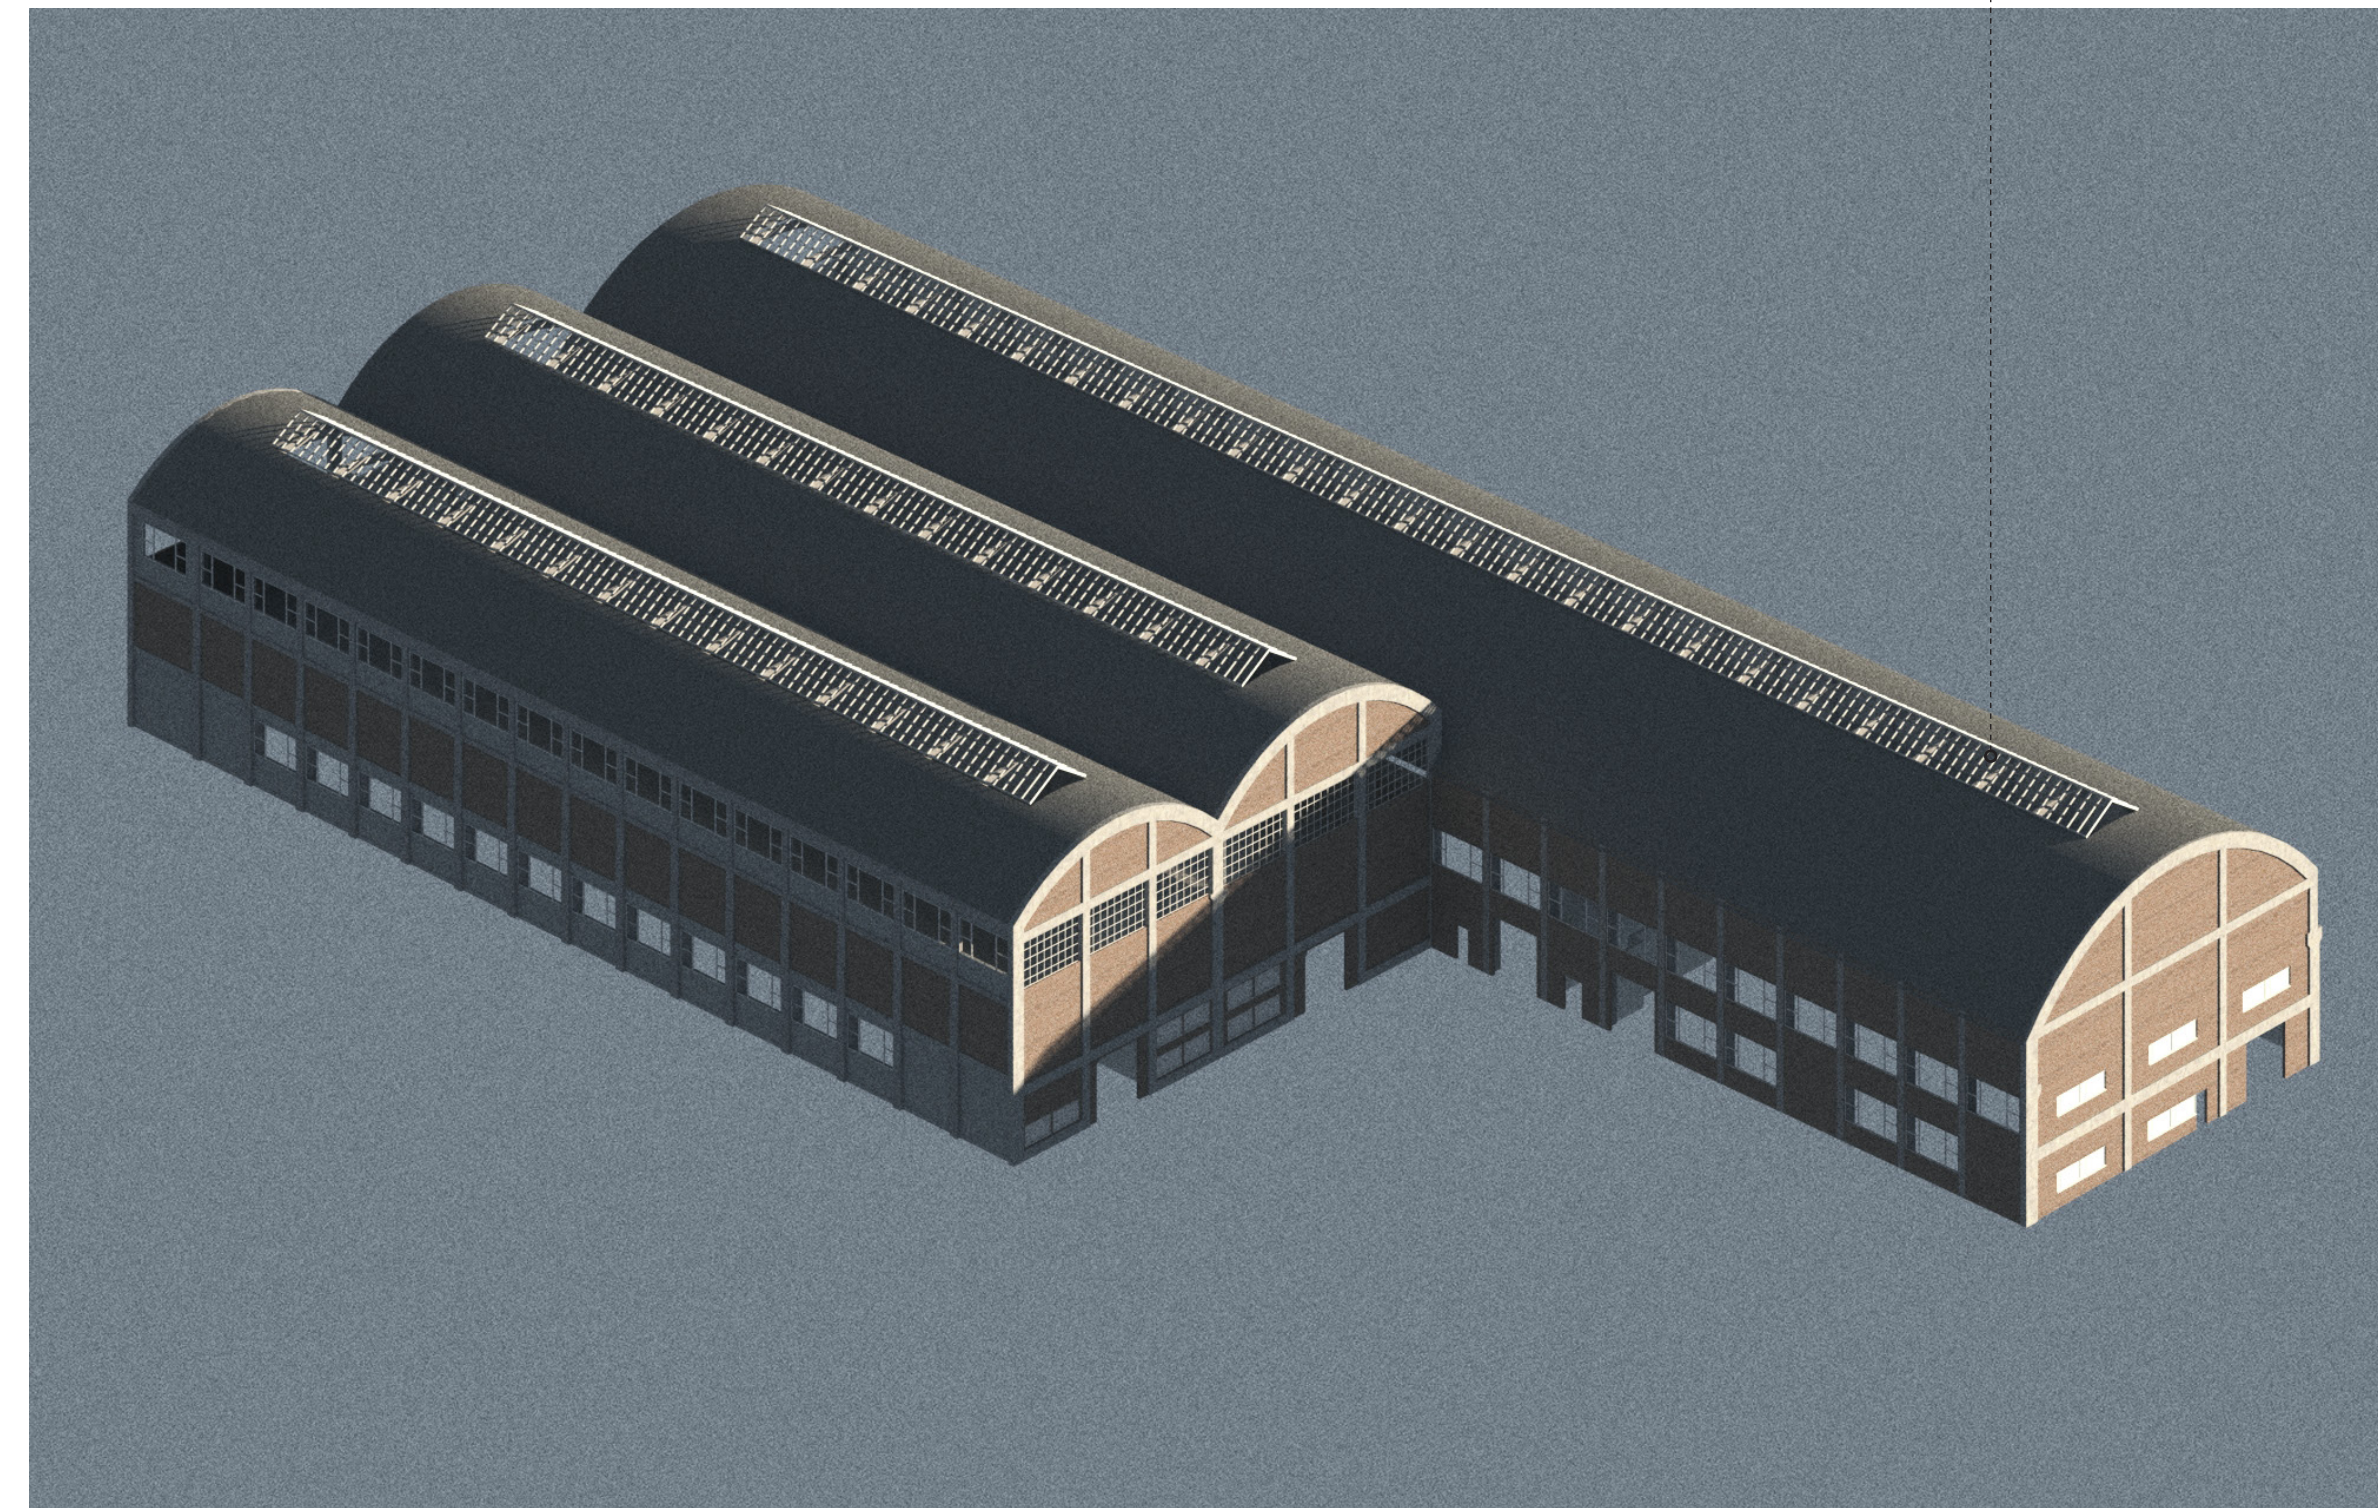
Approx. size of glass panes: 800x2400 624 pcs

Skylights

Module  
size: approx.  
800x2400

Although skylights are present in the original documentation from 1921, they have certainly been replaced in the relatively recent past. Unfortunately, there is no documentation pertaining to the installation of the new skylights but they appear to be a standard glazing construction.

As the skylights are a singular construction running almost the length of each hall, reuse can be challenging with regards to new axis widths, lengths, etc. A viable solution is to remove the glass from the frames and reframe it on-site in the new project.
