# Uppåkra Arkeologiska Center

Prästlönebostället

DIPLOMA FALL 2020

The Oslo School of Architecture and Design

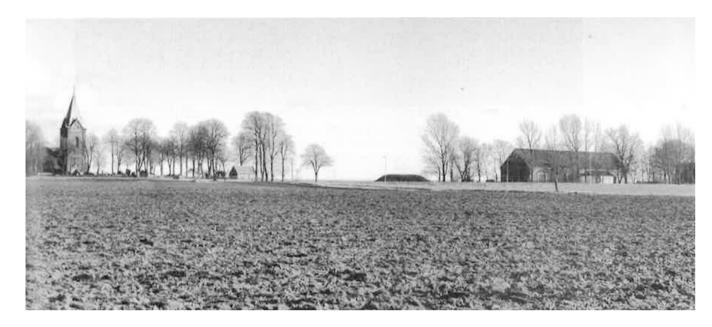
Photo of the barn, church and Storehöj from 1934.

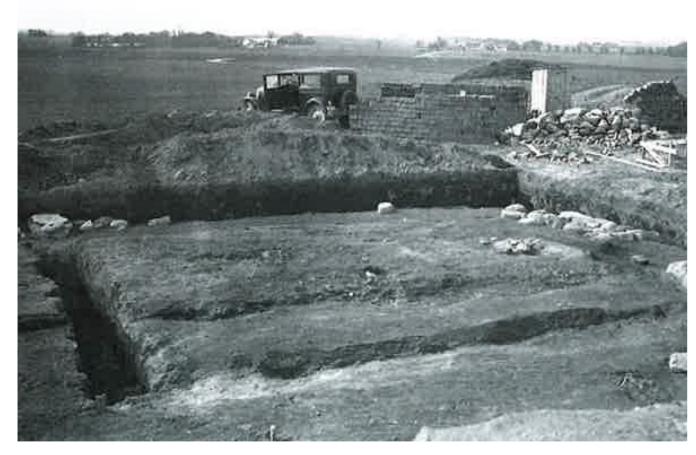
Photo of first archaeological excavations (Vifots Schakt). 1934

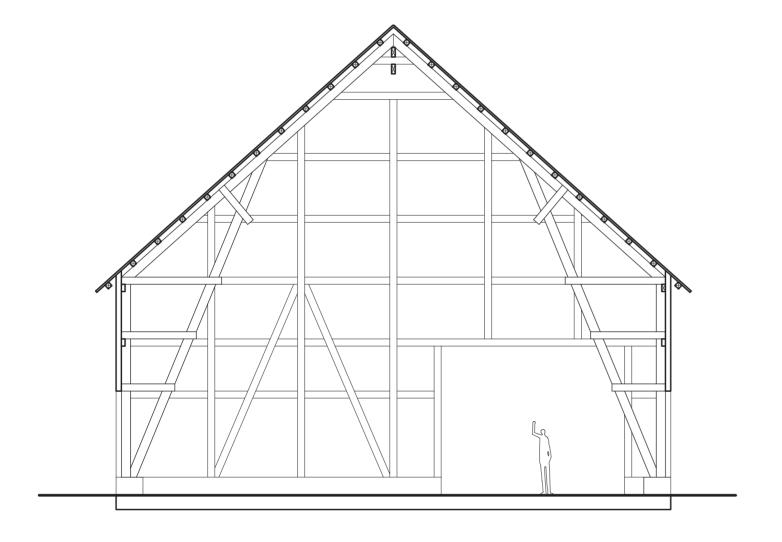
#### Section A - A

Section through the northern part of the building. The span of the structure creates a big, open space with the character of a hall.

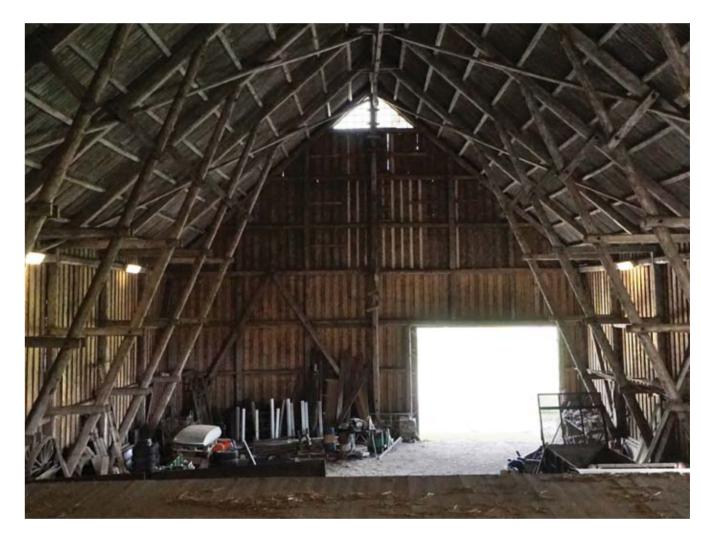
Photo of the northern part of the barn. Taken from the second floor.

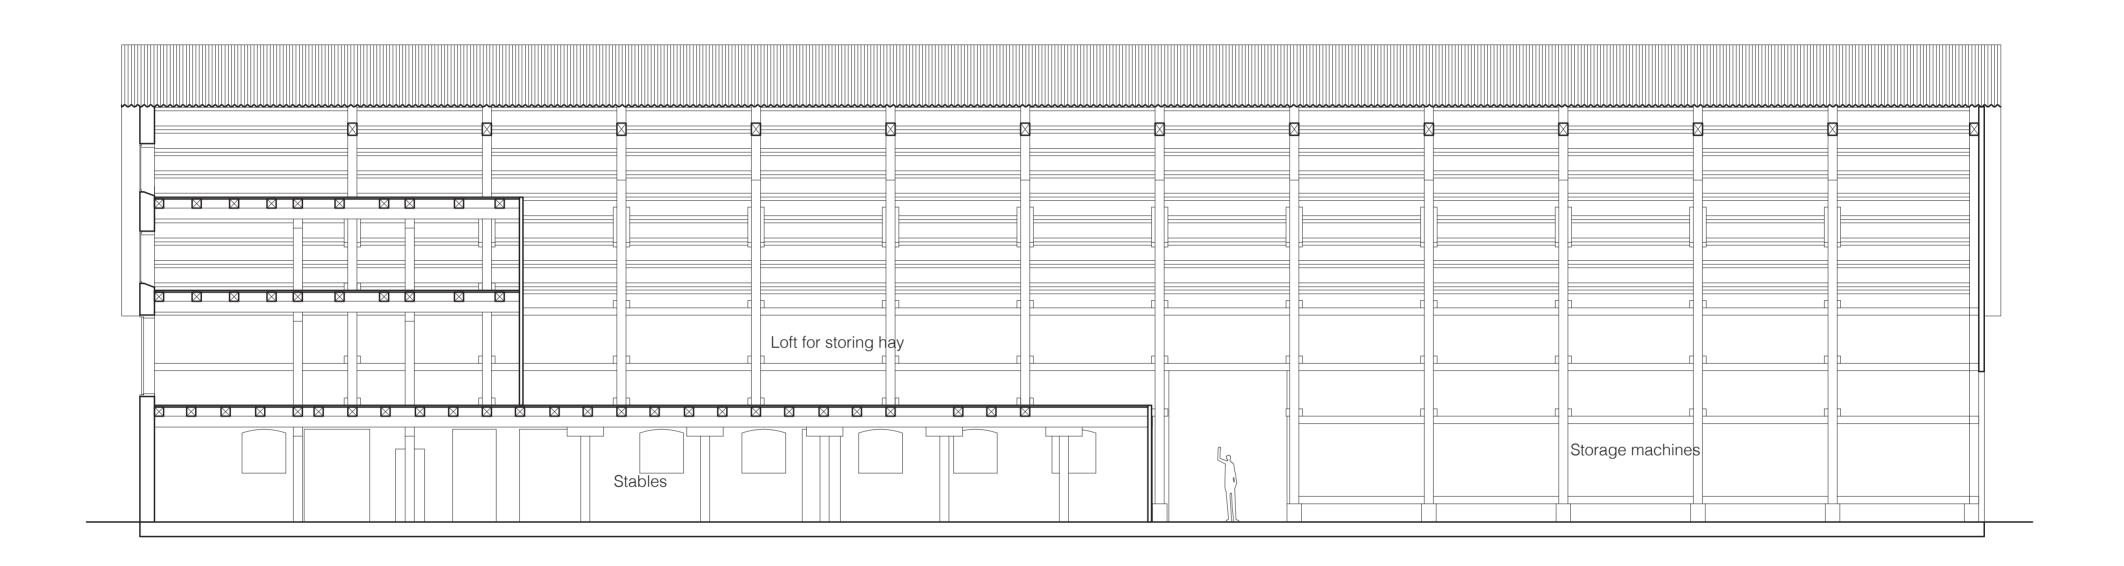
#### Section B - B

Long section through the middle of the barn showing the difference in character between northern and southern part of the building. Northern part expresses a clear, constructive logic, where the structure creates a big open space. Southern part has the same basic structure, but merged with a seconday post and beam system in order to achieve more levels. This disrupts the logic and hampers the potential of having a big, continious space of unusual height and volume that lies in the structure.

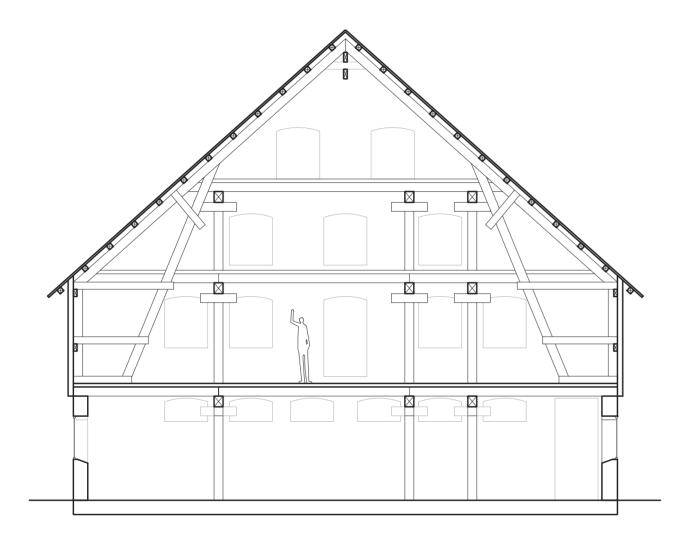
#### **Section C-C**

Short section through the southern part of the building. This part has a somewhat more entagled character, and does not express the same spacoius character as the northern part. Note that the same timber frames are used in both the southern and northern part, but here they have been cut off and merged with a secondary constructive system.

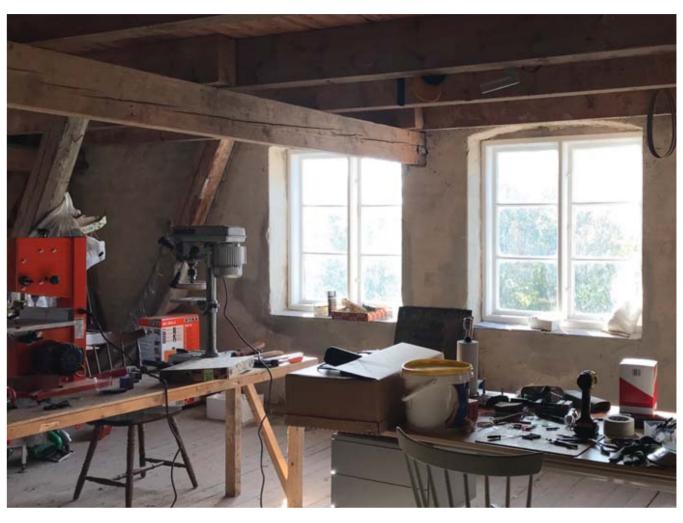
Photo of the third floor in the southern part. Note the big dimension of the timber construction.

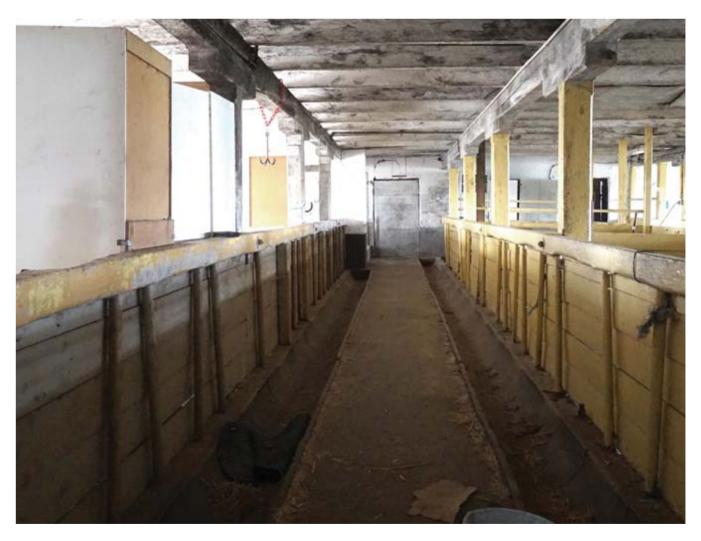
Photo of the former stables in the southern part,

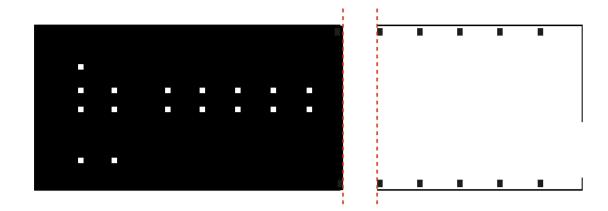
Experienced structure and character of existing state

The two big apertures (one located to the east and the other to the west) creates a corridor effectingly separating the barn into a northern and a southern part. The separation is further enhanced as each part, even though operating within the same system, expresses it's own character and logic.

**The northern part** expresses a clear constructive logic, where the timber frames creates a big open space under their span. It has the character of a hall - an easily percieved big, open, continuous space. As one's eyes is drawed up to the big height of the room, the timber construction itself becomes exhibited. The space is dark, as there are few windows.

The southern part operates within the same constructive system as the northern part, but the logic seems to have been lost. If the northern part is percieved as one, unambigious space, the southern part has a more complex character with a mix of different levels and room sizes. Here, the clear rythm of the timber frames is disrupted, and the open space created by the structure is lost, as it is merged with a secondary post-beam system carrying the inserted floors. The southern part bears marks from being changed and adapted to alternate uses over it's lifetime. It's past function as a stable can be traced in the gates and open boxes (for horses), while later added partition walls seems to have lost it's original purpose. This gives the southern part an entagled character - a sequence of spaces that does not make sense in relation to each other. The southern part is lighter than the northern, as the brick walls are enriched with windows. However, this is somewhat dampened by variations in levels and partition walls. The daylight is not evenly distributed. The height of the floors vary, but are unsufficient to accomodate the standards of a modern program with demands on a climatic shell supported by technical infrastructure.

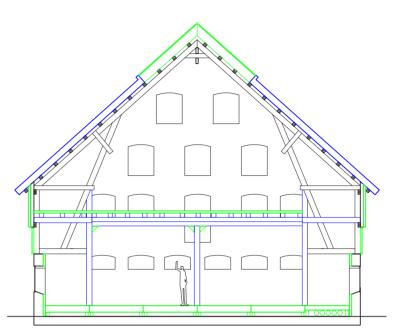
A new built-up floor is added on top of the existing concrete floor, leaving a gap in between. The new floor consists of 180 cm CLT elements that also provide heat insulation. The reason of adding a new floor floating above the existing is to avoid having to excavate the entire footprint of the barn, which would have to been done if the existing floor was to be removed. By adding a new floor above the existing barn floor, extensive, new foundation work is avoided. The void between the floors is utilized for technical infrastructure, again preventing work in the ground.

If necessary, the brick walls will get an insulating and easily removable layer on the inside. The inner surface should be rendered to maintain the masonry character. While the wooden cladding also is re insulated, the wooden panels are preseved and re-used, keeping the expression of the materials in the facade.

Two continous bands of windows are added, stretching the full length of each side of the barn. They add daylight to the spaces along the brick walls. A continous skylight along the ridge of the barn provides generous dayligh to the café, exhibitions and loft areas. It also binds together the northern and southern parts of the barn.
