The bicycle trip

The barn in Rendalen

The pod

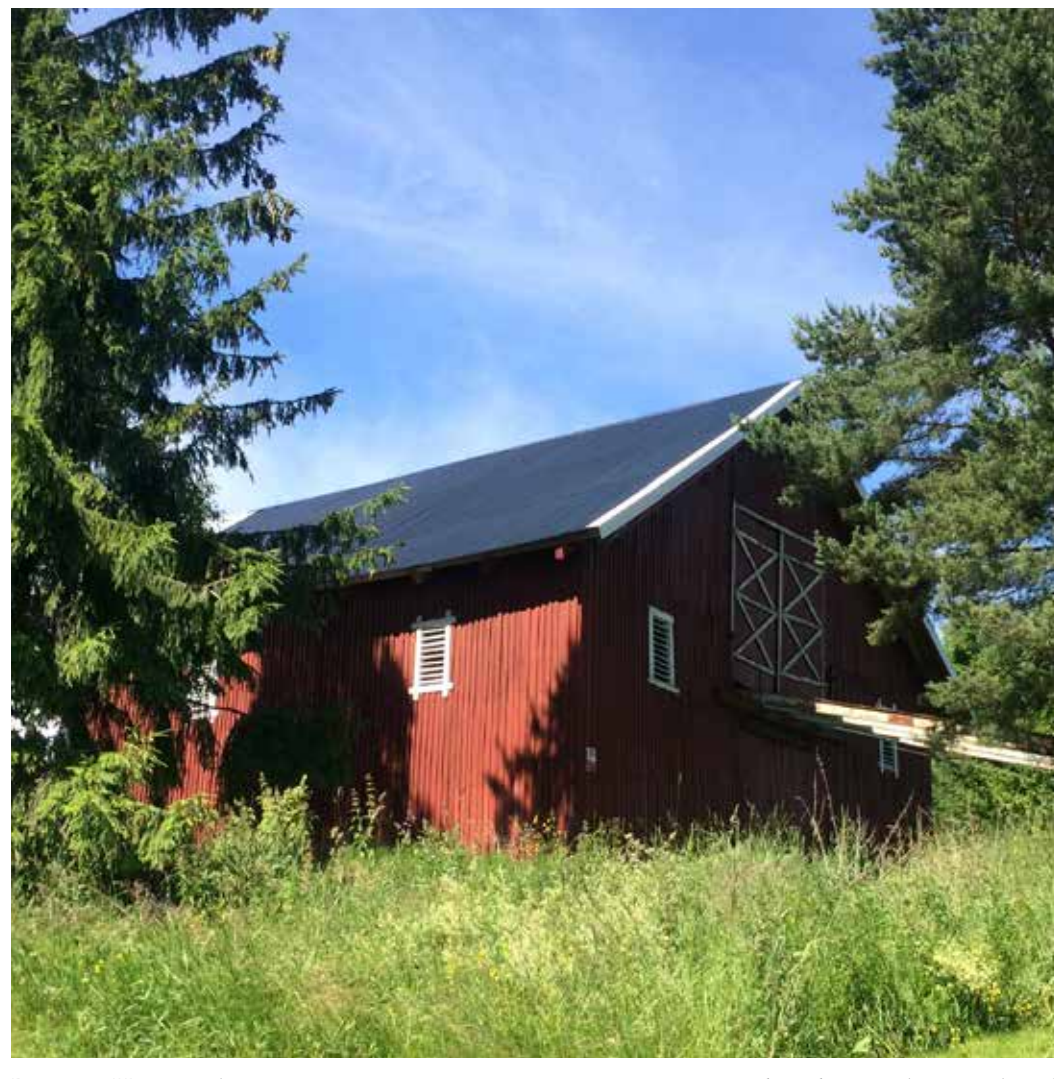
Barn near Beret with an active program, an open structure in good condition with minimal need of maintenance. Property: 12496.

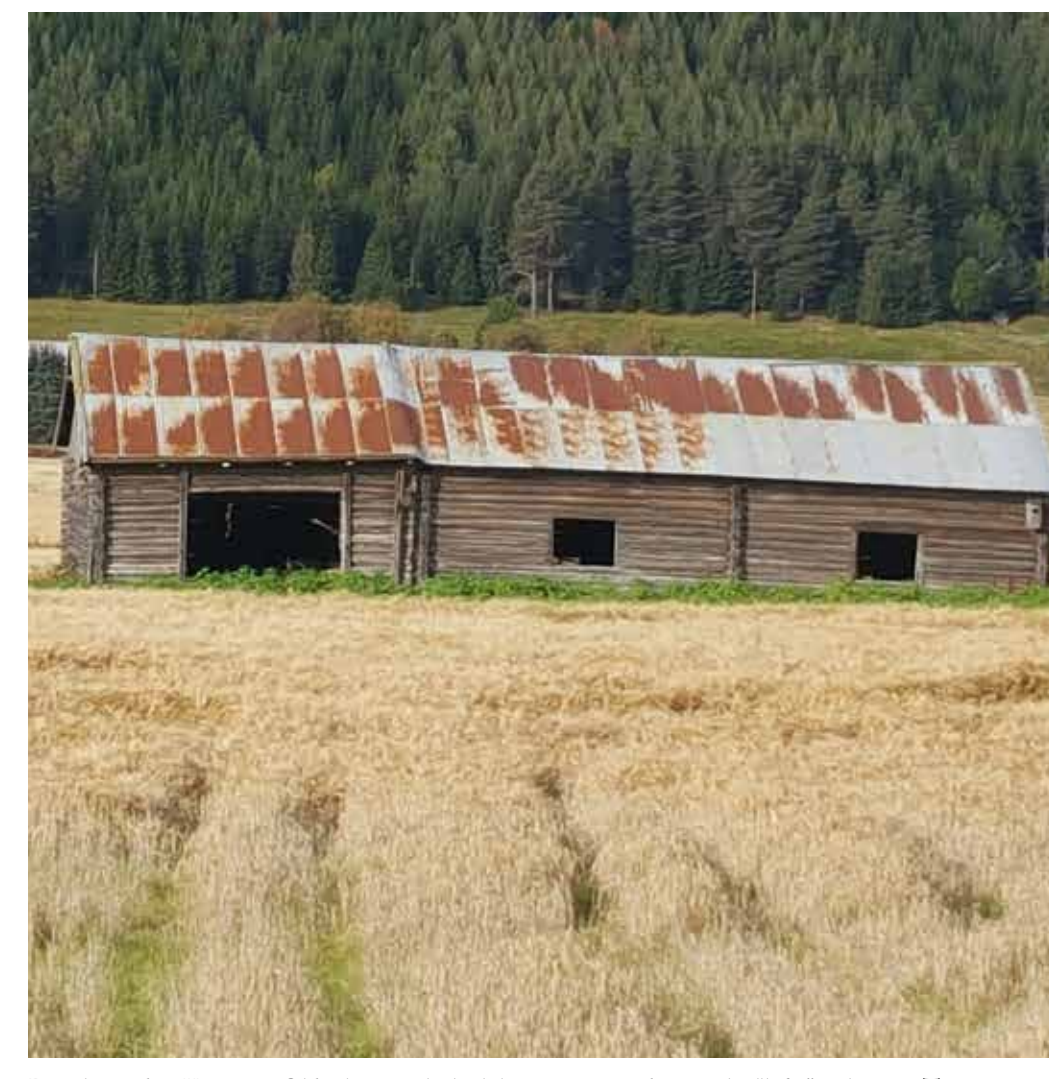
Barn located in Ekeberg. Older barn with high quality construction using the 'tjelle' technique. The structure is sturdy, dry, and well-maintained. The barn consists of three smaller sections with an old storage. Property: 12497.

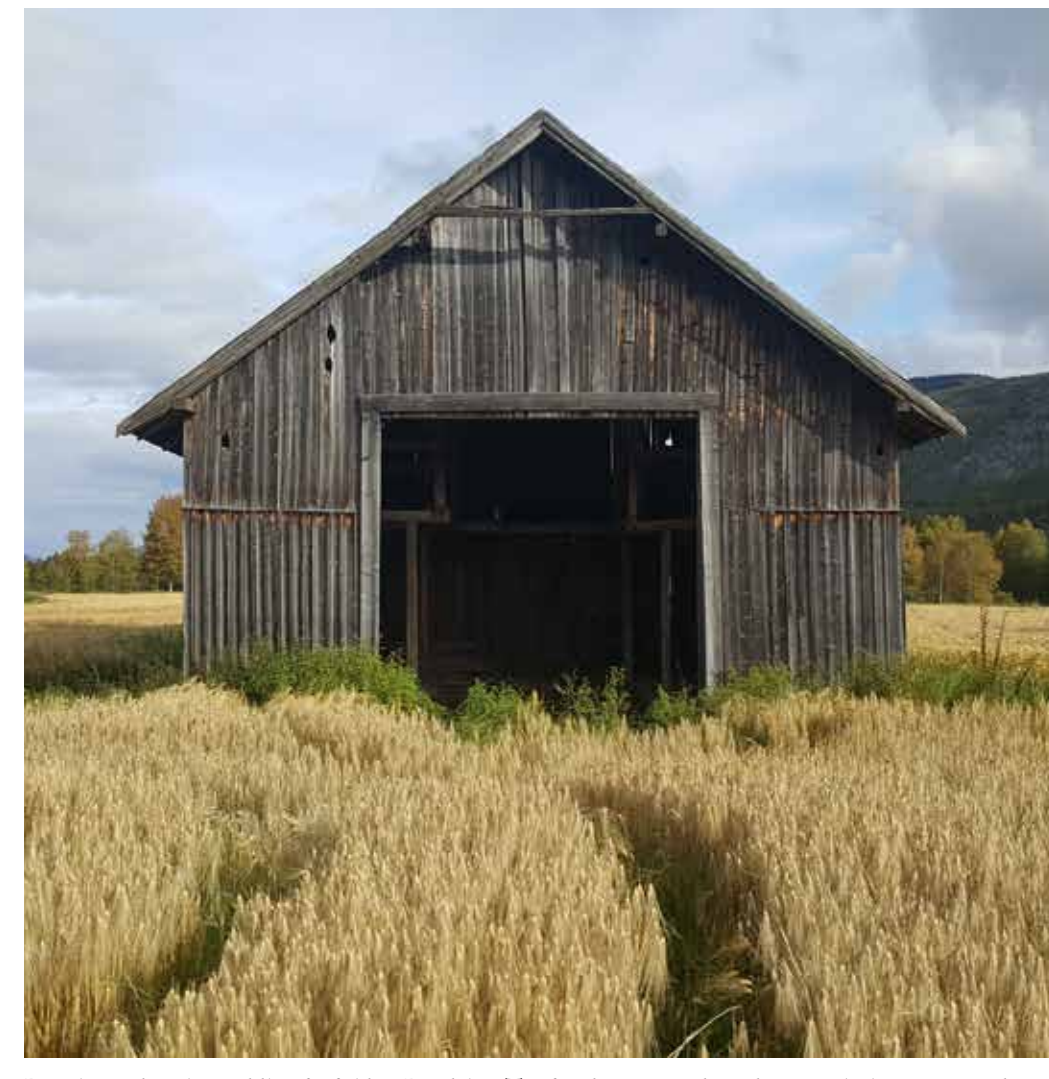
Barn located in the middle of a hill in Beret. The barn is in good condition with the same wooden structure 100 years. One big open room will need some refurbishment and there is an active program using the 'tjelle' technique.

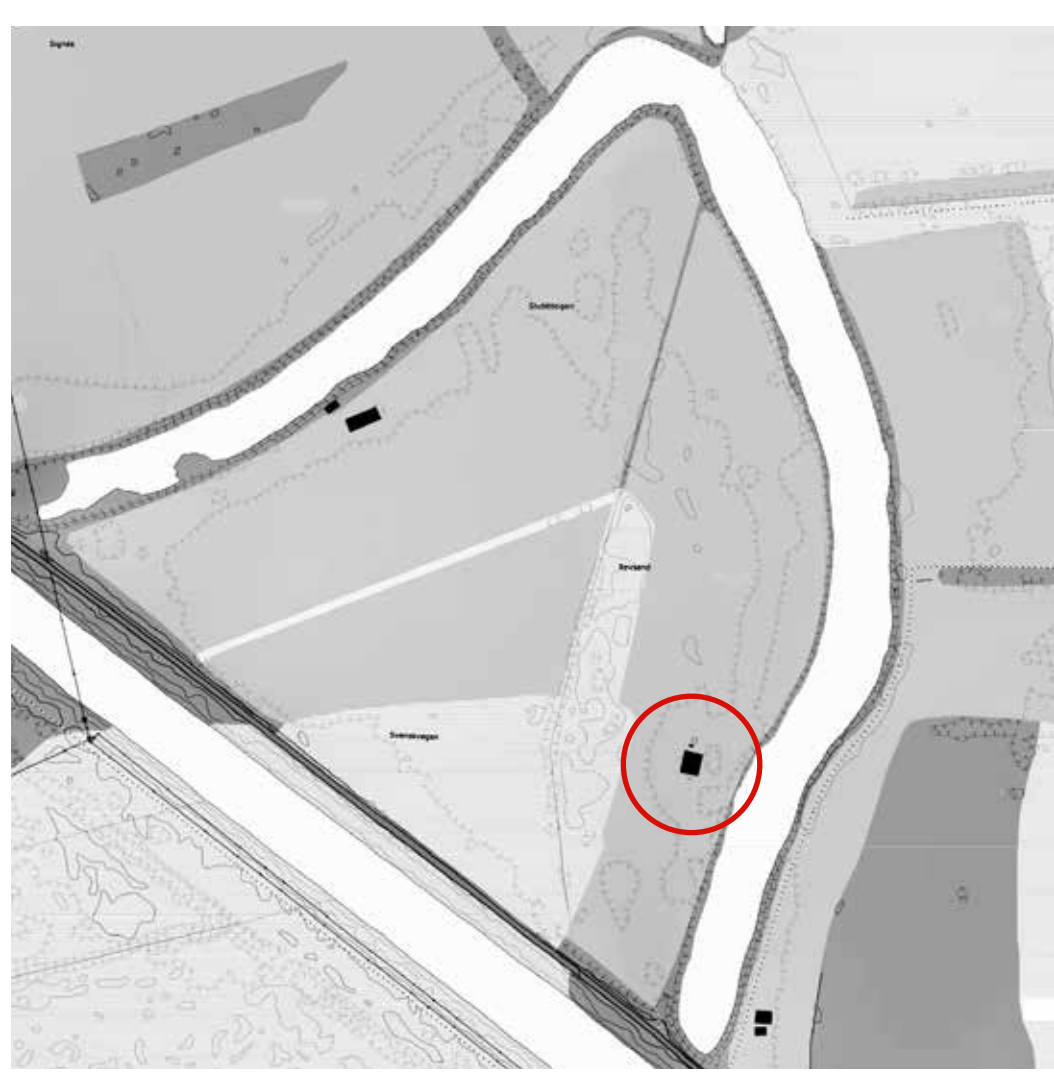
Site plan showing the barn in the middle of the field in Beret.
